Appendix E

Harford Transit LINK

Stop Improvement Profiles

Harford Transit LINK Potential Transfer Stops

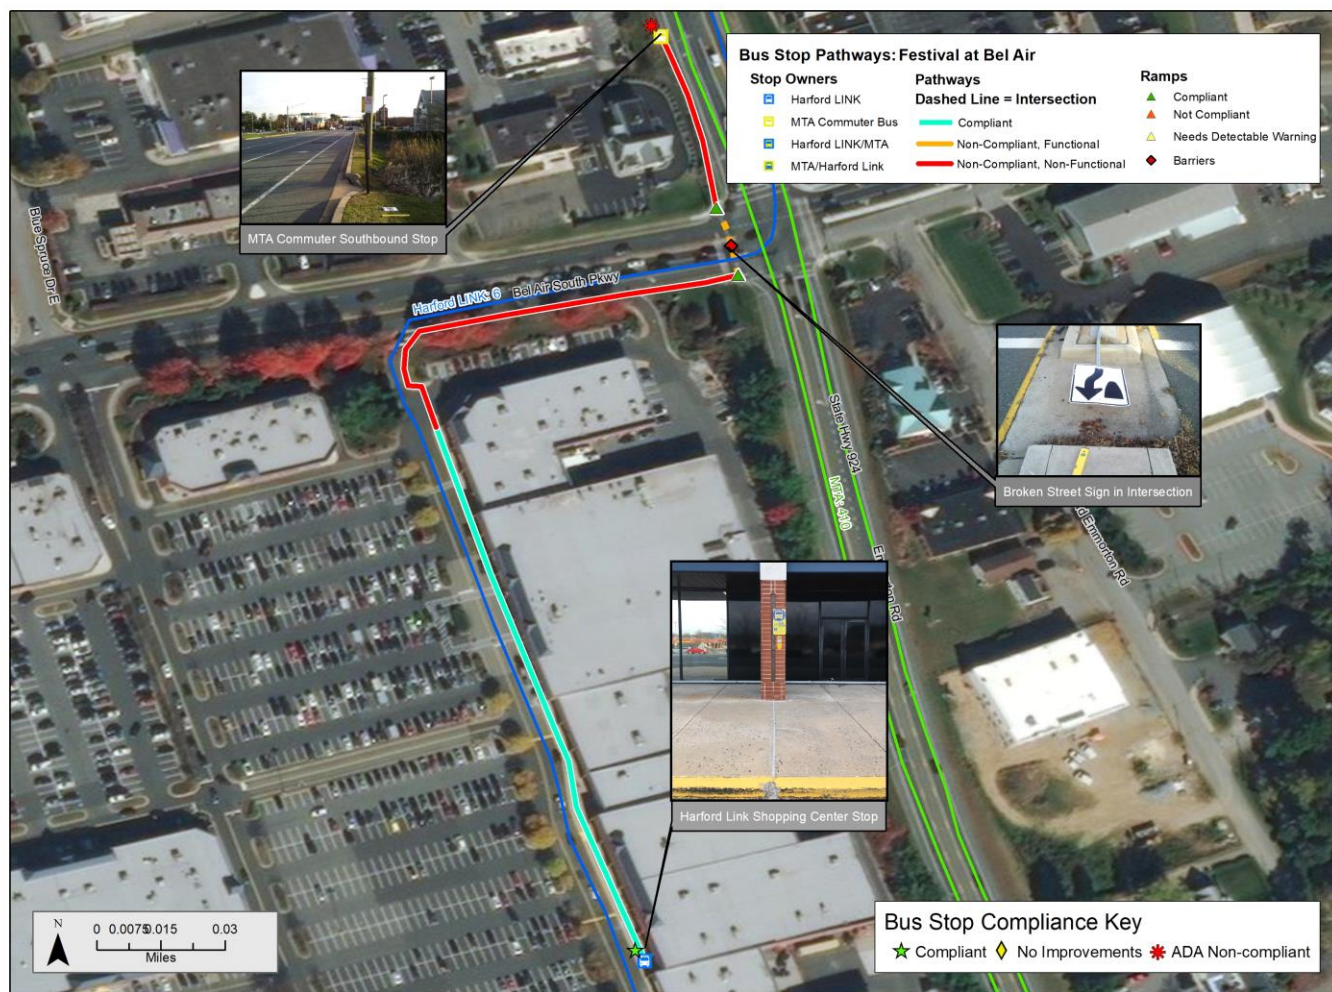
Landing Pads Needed:	1	Curb Ramps to Install:	0
Sidewalk (ft) to be installed/repaired:	670	Detectable Warnings Needed:	0
Signs with Non-Compliant Height:	0	Consolidate Signage?	Yes
New Signs Needed:	No	Pedestrian Control:	Yes
Compliant Amenities:	Yes	Traffic Control:	Yes

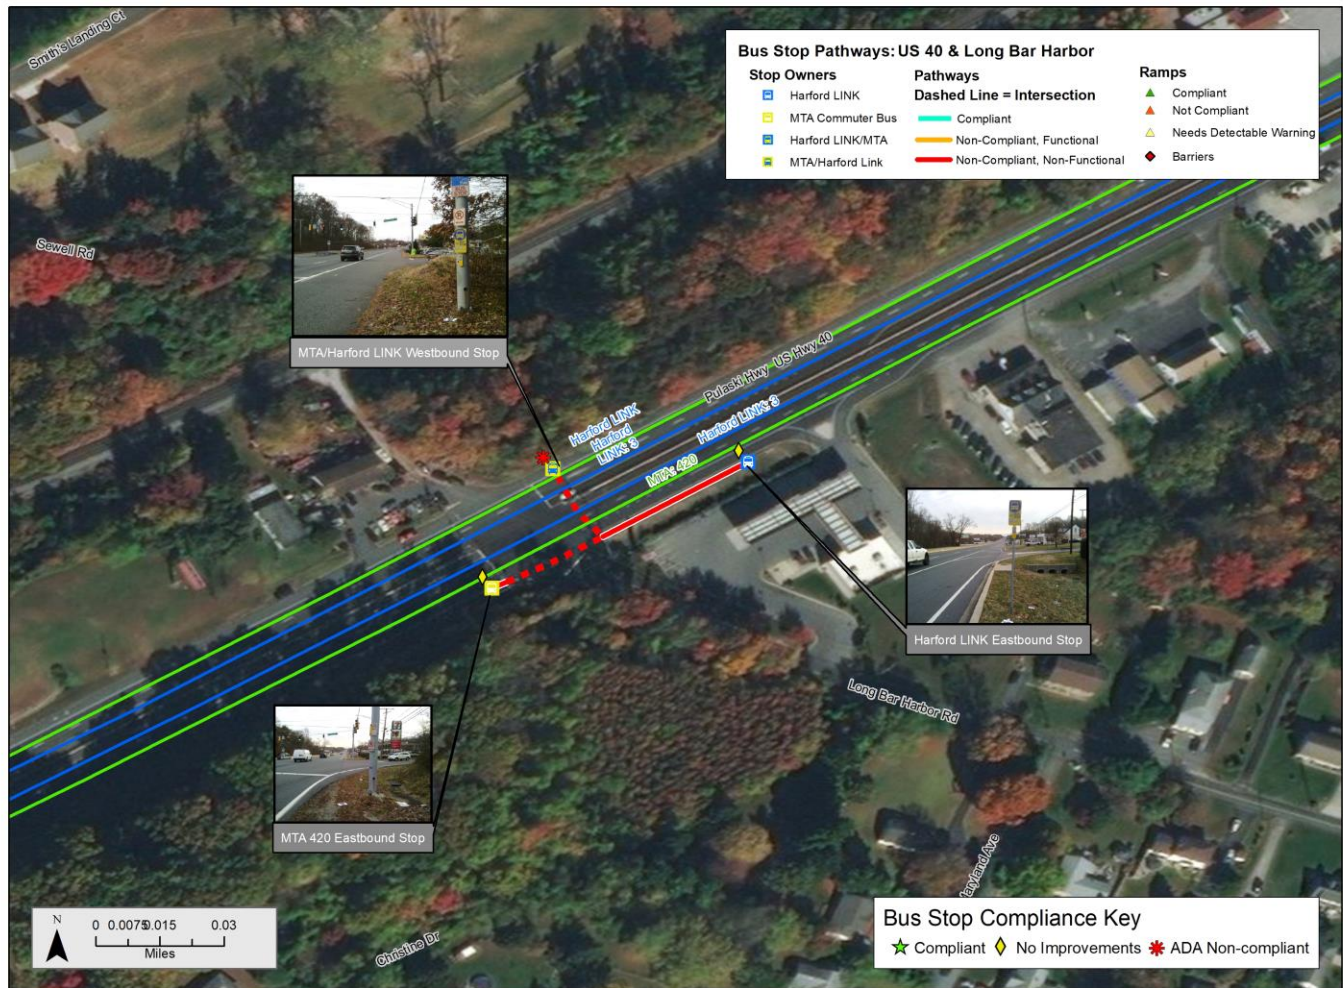
Landing Pads Needed:	3	Curb Ramps to Install:	3
Sidewalk (ft) to be installed/repaired:	160	Detectable Warnings Needed:	3
Signs with Non-Compliant Height:	1	Consolidate Signage?	Yes
New Signs Needed:	Yes	Pedestrian Control:	No
Compliant Amenities:	NA	Traffic Control:	Yes

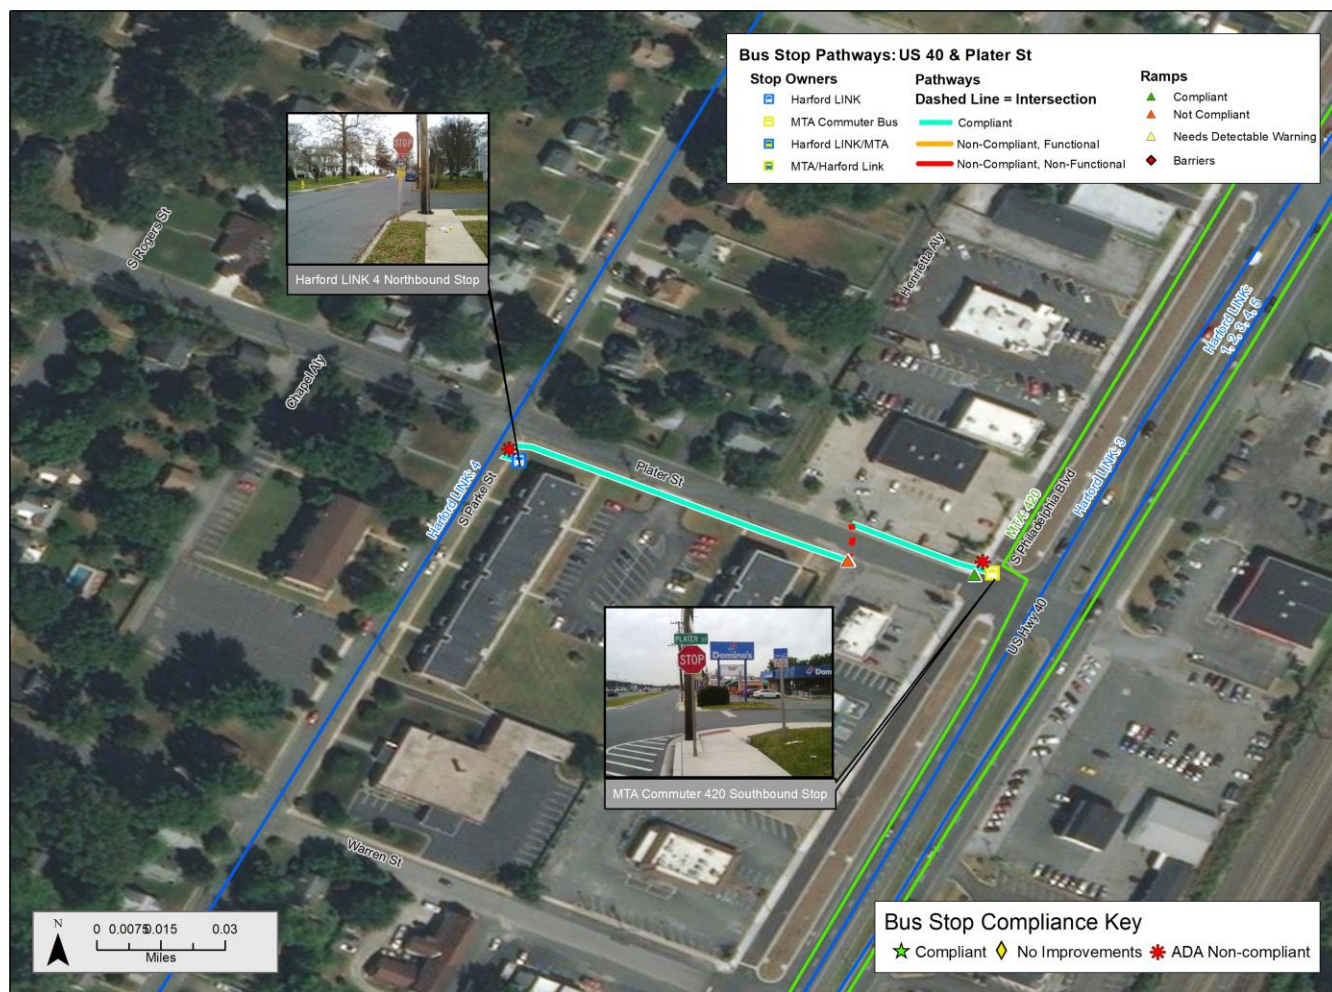
Landing Pads Needed:	1	Curb Ramps to Install:	2
Sidewalk (ft) to be installed/repaired:	0	Detectable Warnings Needed:	2
Signs with Non-Compliant Height:	2	Consolidate Signage?	Yes
New Signs Needed:	Yes	Pedestrian Control:	No
Compliant Amenities:	NA	Traffic Control:	No
