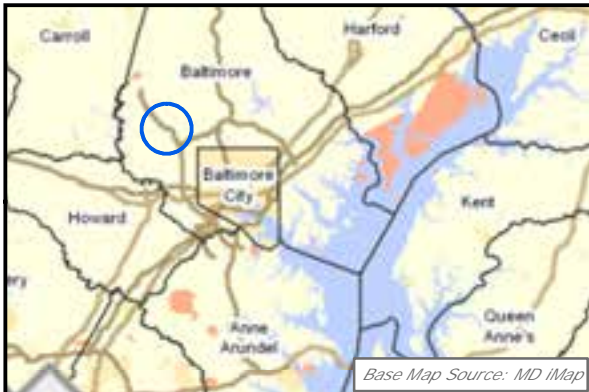
Existing Conditions
Station: Owings Mills
Rail Line: Metro

The station is situated in a low lying area. Metro and freight rail lines create a physical barrier between the station and communities to the east. Customers coming from the east (Pikesville business district) must use the Milford Mill Road bridge to reach the station. The bridge has sidewalks. There are good sidewalk connections to the communities situated to the west and north of the station. The pedestrian conditions are generally adequate but there is evidence of needed maintenance/repairs.

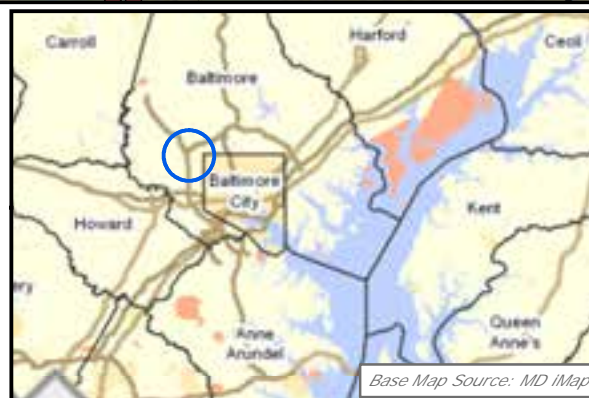
Station: Old Court
Rail Line: Metro

The station is situated in a low lying area. Metro and freight rail lines create a physical barrier between the station and communities to the east. Customers coming from the east (Pikesville business district) must use the Milford Mill Road bridge to reach the station. The bridge has sidewalks. There are good sidewalk connections to the communities situated to the west and north of the station. The pedestrian conditions are generally good but there is evidence of needed maintenance/repairs.

PEDESTRIAN DEFICIENCIES

- At the station a faded crosswalk should be replaced and some curb ramps are needed.
- Street lighting is not provided and is recommended for the bus stop located at the intersection of Greenwood Road and Old Court Road.

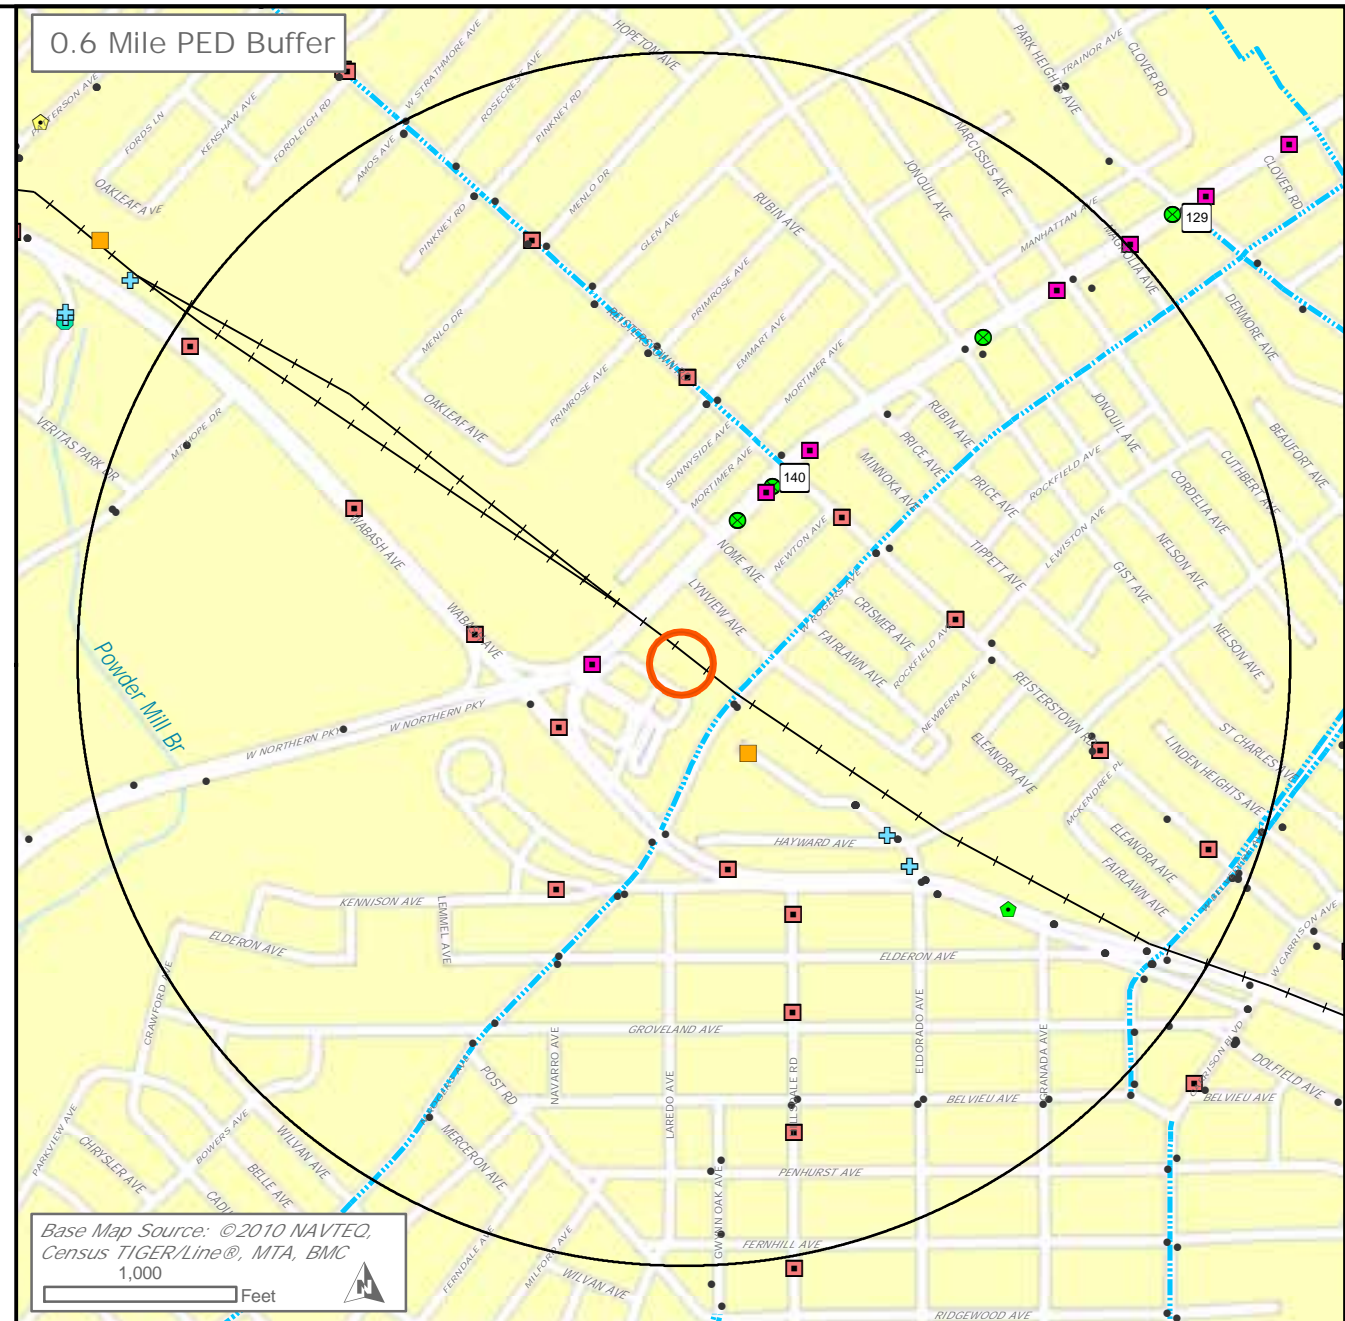
Existing Conditions
Station: Rogers Ave
Rail Line: Metro

- To address safety issues, a sidewalk should be provided on Wabash Ave from Eldorado to W Belvedere Ave.
- Faded crosswalks in the vicinity of the station should be replaced.
- Pedestrian crossing signs are recommended at the station entrance.
- There are some missing curb ramps within the station site and at the intersection of Patterson and Eberle.

- For bike lanes on Kennison Ave and North Rogers Ave, bicycle signage and drainage improvements are needed.
- For shoulder use by bicyclists on Beethoven Ave and Gwyn Oak Ave signage and drainage improvements are recommended.
- For use of wide outside lane by bicyclists the following roads are recommended for Share the Road signage/markings and some need drainage improvements Glenn Ave, Liberty Heights Ave, Park Heights Ave, Wabash Ave, West Northern Parkway.
- Information on bicycle locker rental/usage should be posted at the station.
