RAIL LINE: Light Rail

STATION PROFILE: Patapsco

For more detailed information refer to the project database.

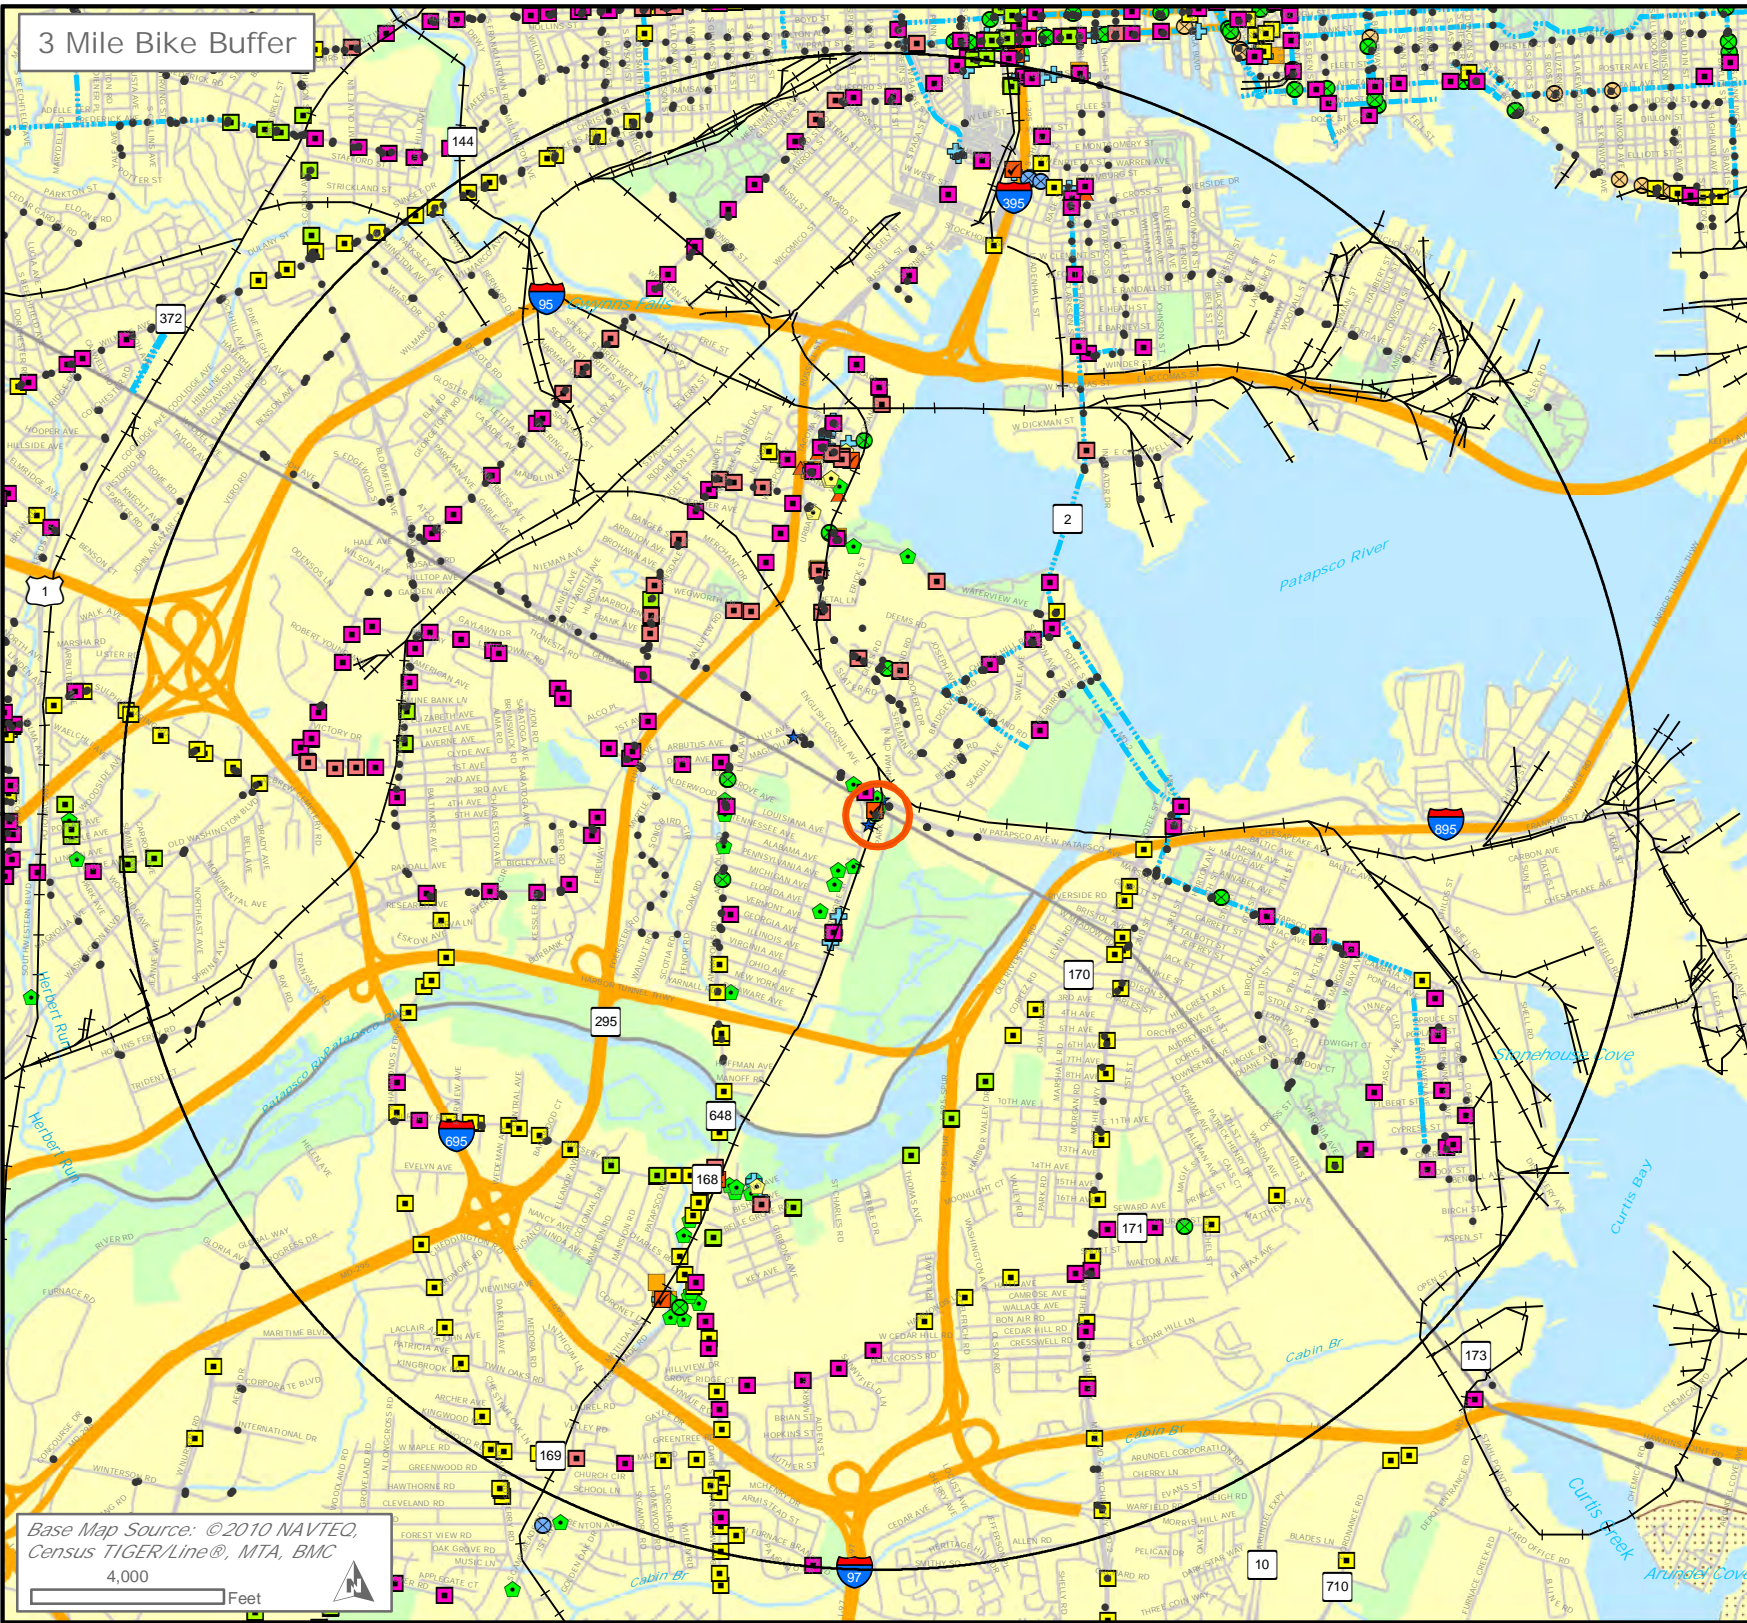
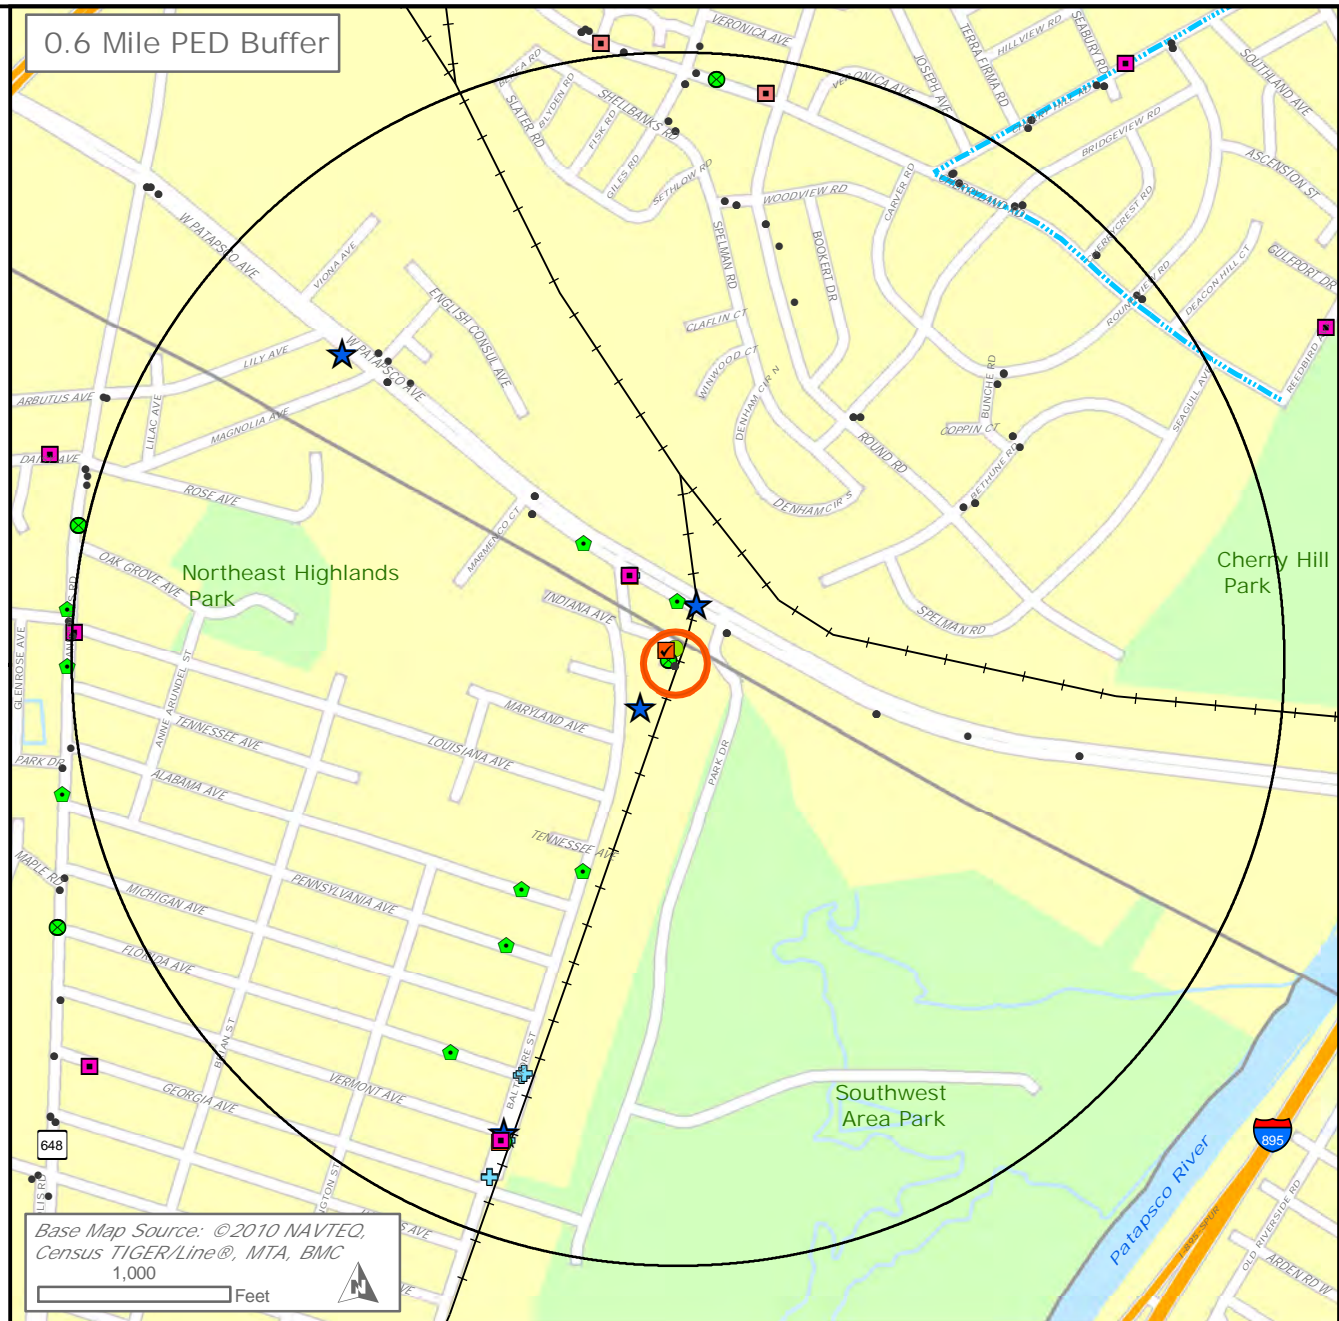
## Existing Conditions

There is no pedestrian connection from the station to the surrounding communities. No sidewalk exists on W Patapsco Avenue beyond the station property. There are residential neighborhoods on the southwest as well as to the northeast within 0.6 miles radius of the station. The neighborhood to the northeast is separated from this area by the railroad track. No pedestrian connections were observed to the station from these communities.

The majority of streets north of the track have sidewalks on both sides while only a few streets south of the track have sidewalks on either side.

- Sidewalks are missing and should be provided on Patapsco Ave from the station to Viona Ave and Potee Street. This may help address the frequency of crashes in this segment.
- Sidewalks are missing along Annapolis Road from Alabama to Virginia and should be provided for improved safety.
- Since people were observed walking along the light rail tracks from the Cherry Hill community it is recommended that a fence be installed for safety.
- Crosswalks and pedestrian crossing signs are recommended at the station entrance.

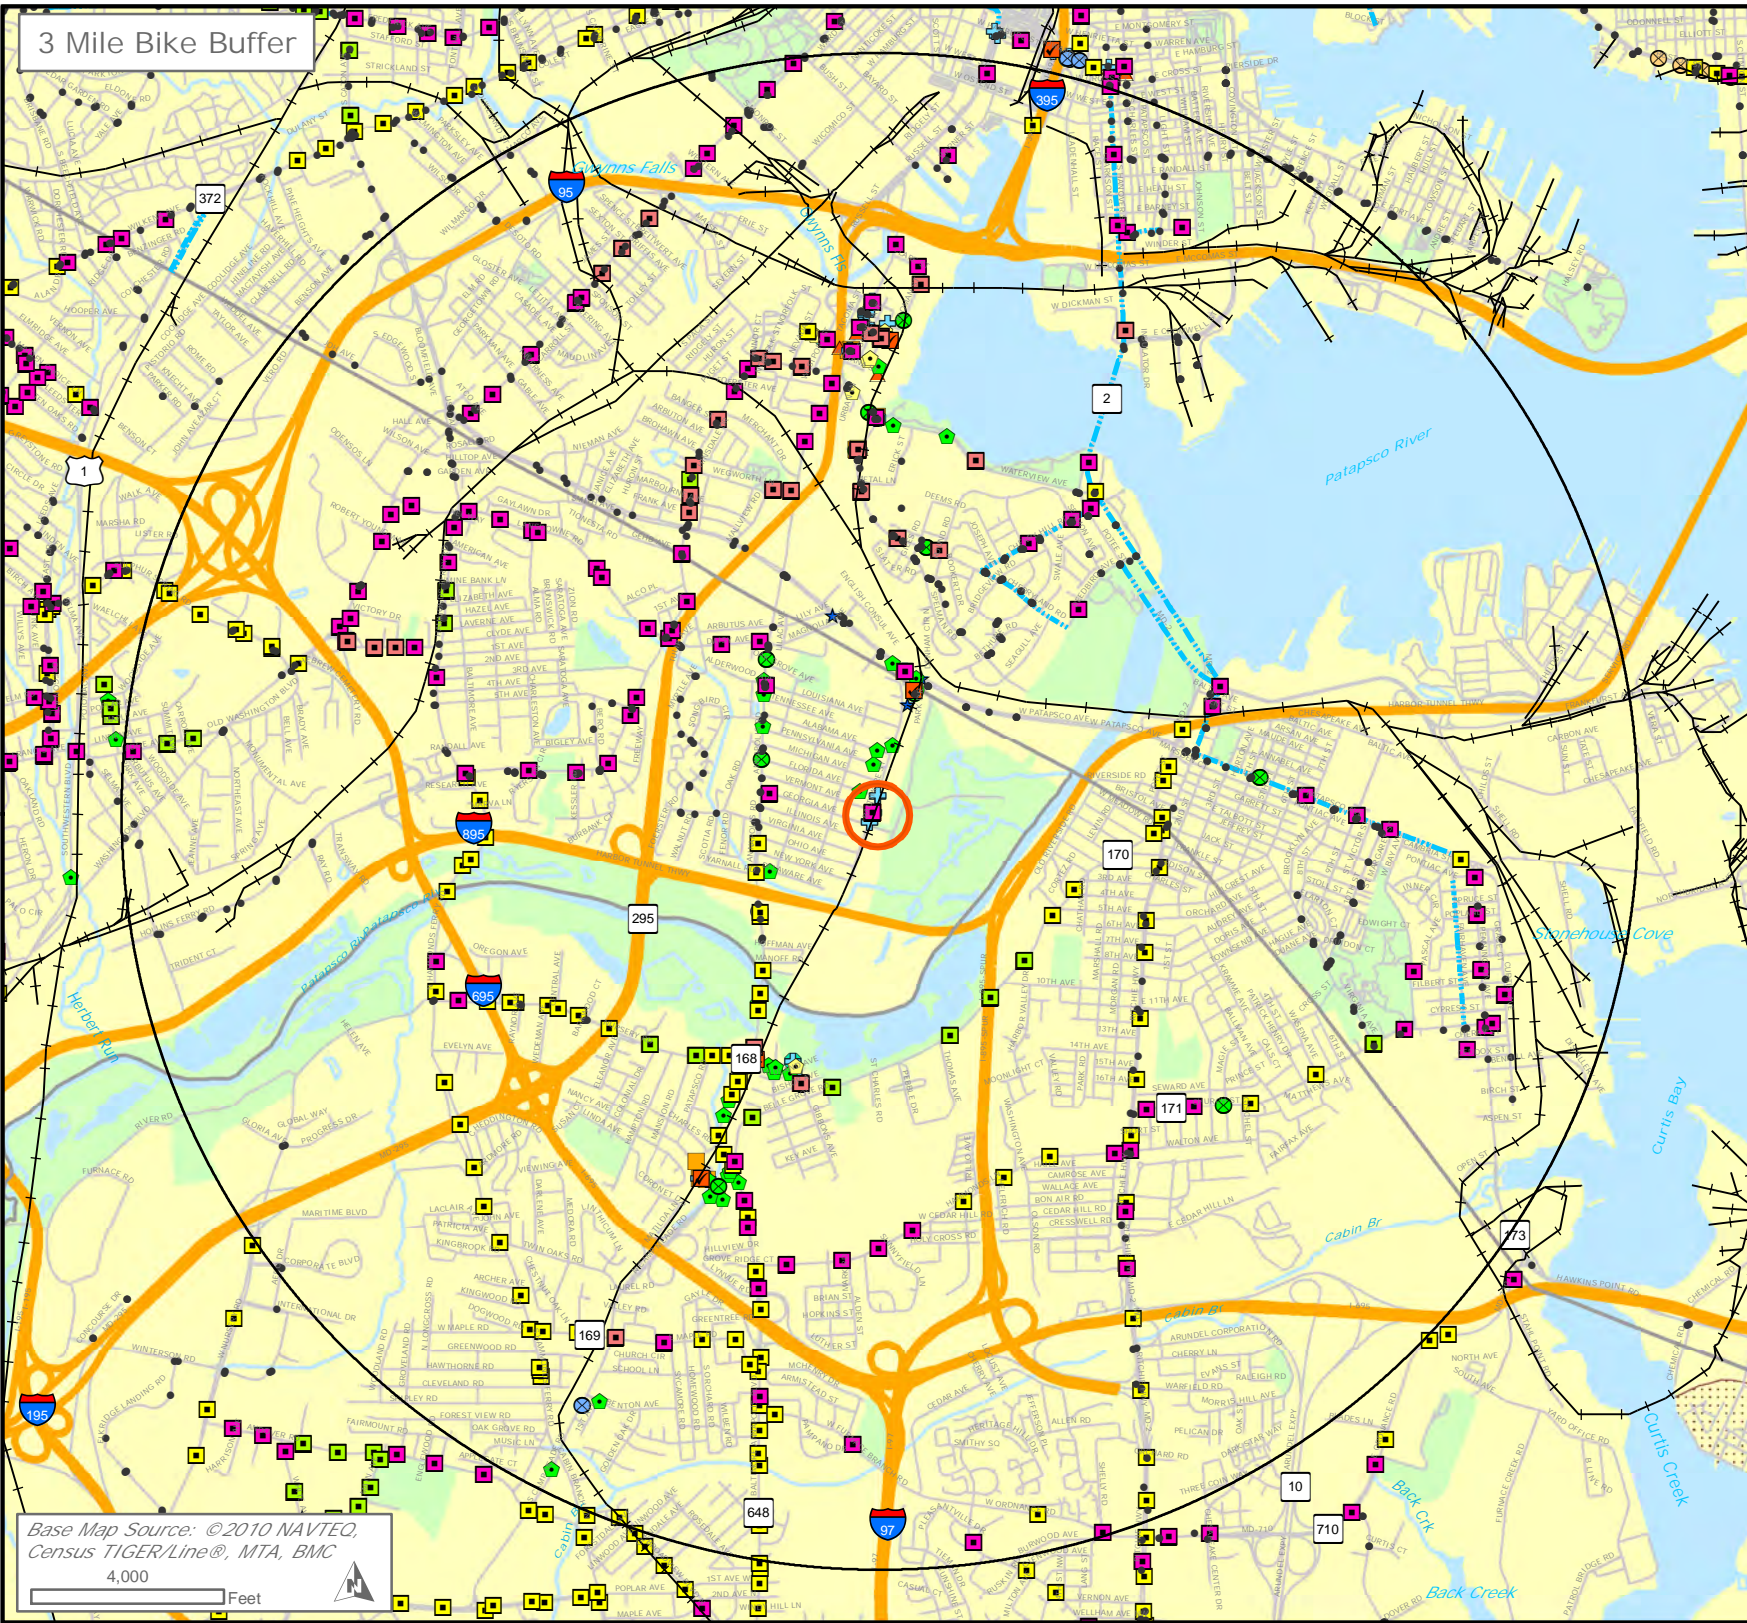
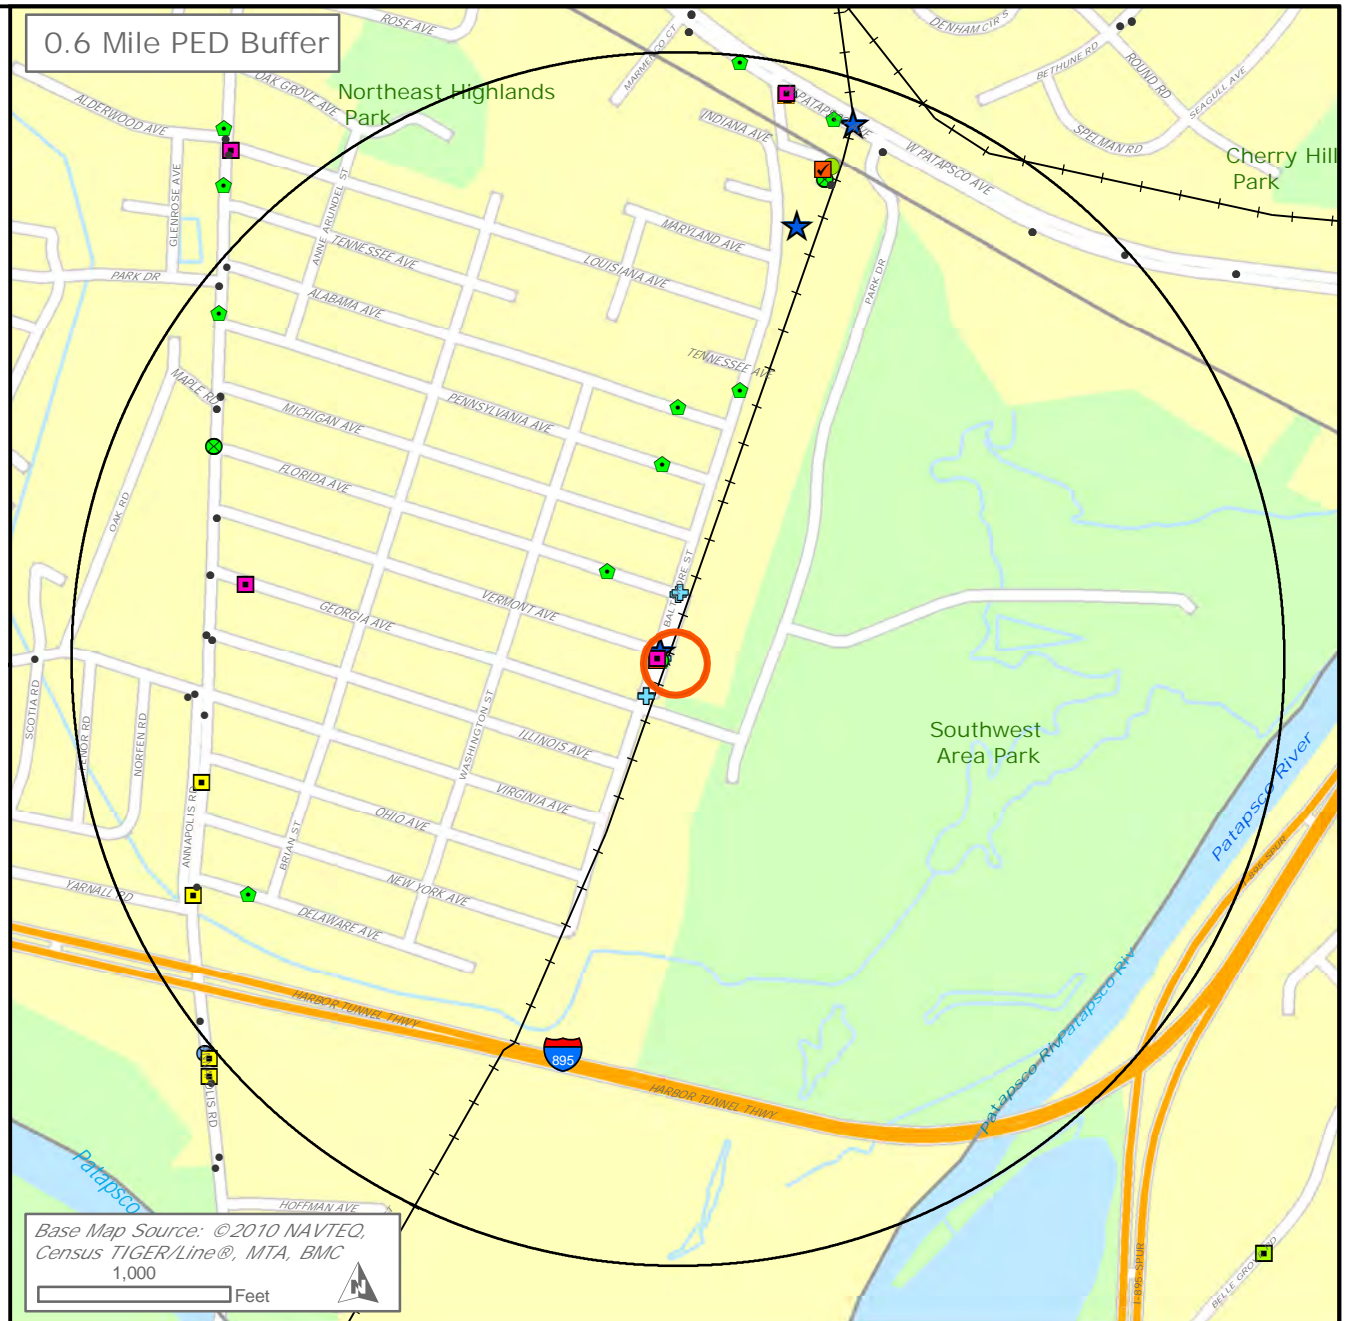
Existing Conditions

The pedestrian environment around Baltimore Highlands light rail station is poor. This station serves a large, older residential neighborhood that lacks sidewalks. One of the major roads that provide access to the station has sidewalks on both sides at some stretches and on one side at others.

- There are a number of long segments of road that lack sidewalks in the area of Baltimore Street and Annapolis Road. The needed sidewalk locations have been identified.
- A designated pedestrian path is recommended within the station parking lot to the platform.
- A crosswalk and pedestrian crossing signs are recommended at the station entrance.

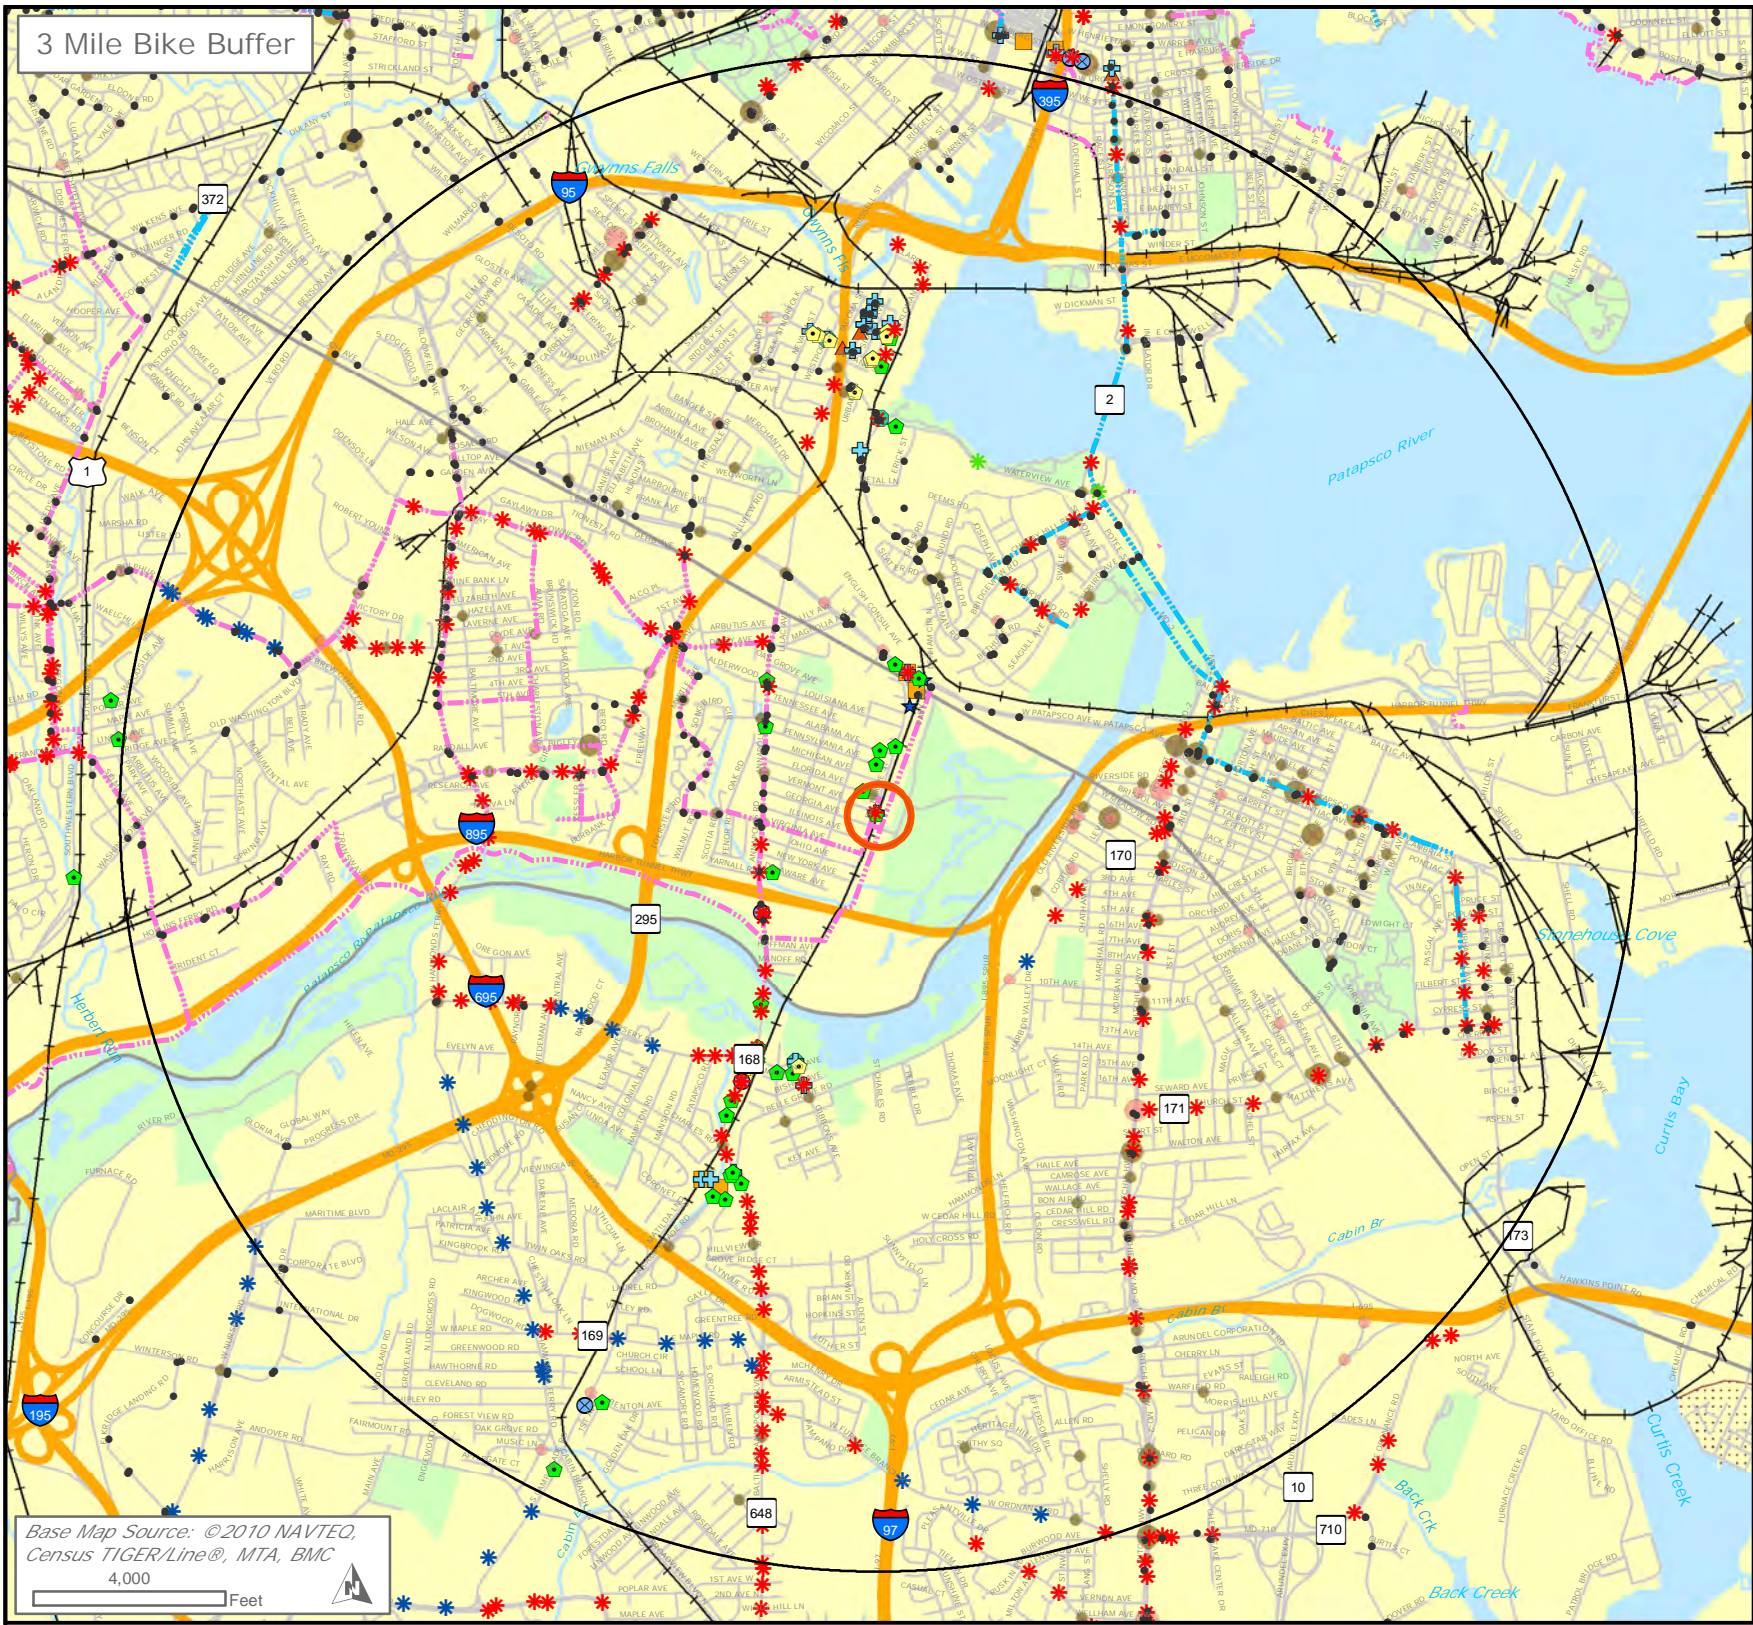
# Recommended Improvements

- To support shared use lanes on the following roads, Share the Road signage and marking is recommended on: Hammonds Ferry Road from Old Hammonds Ferry to Lansdowne Road; on Hollins Ferry Road, on MD 648; on Lansdowne Road; on Baltimore Street and on other roads that have been identified.

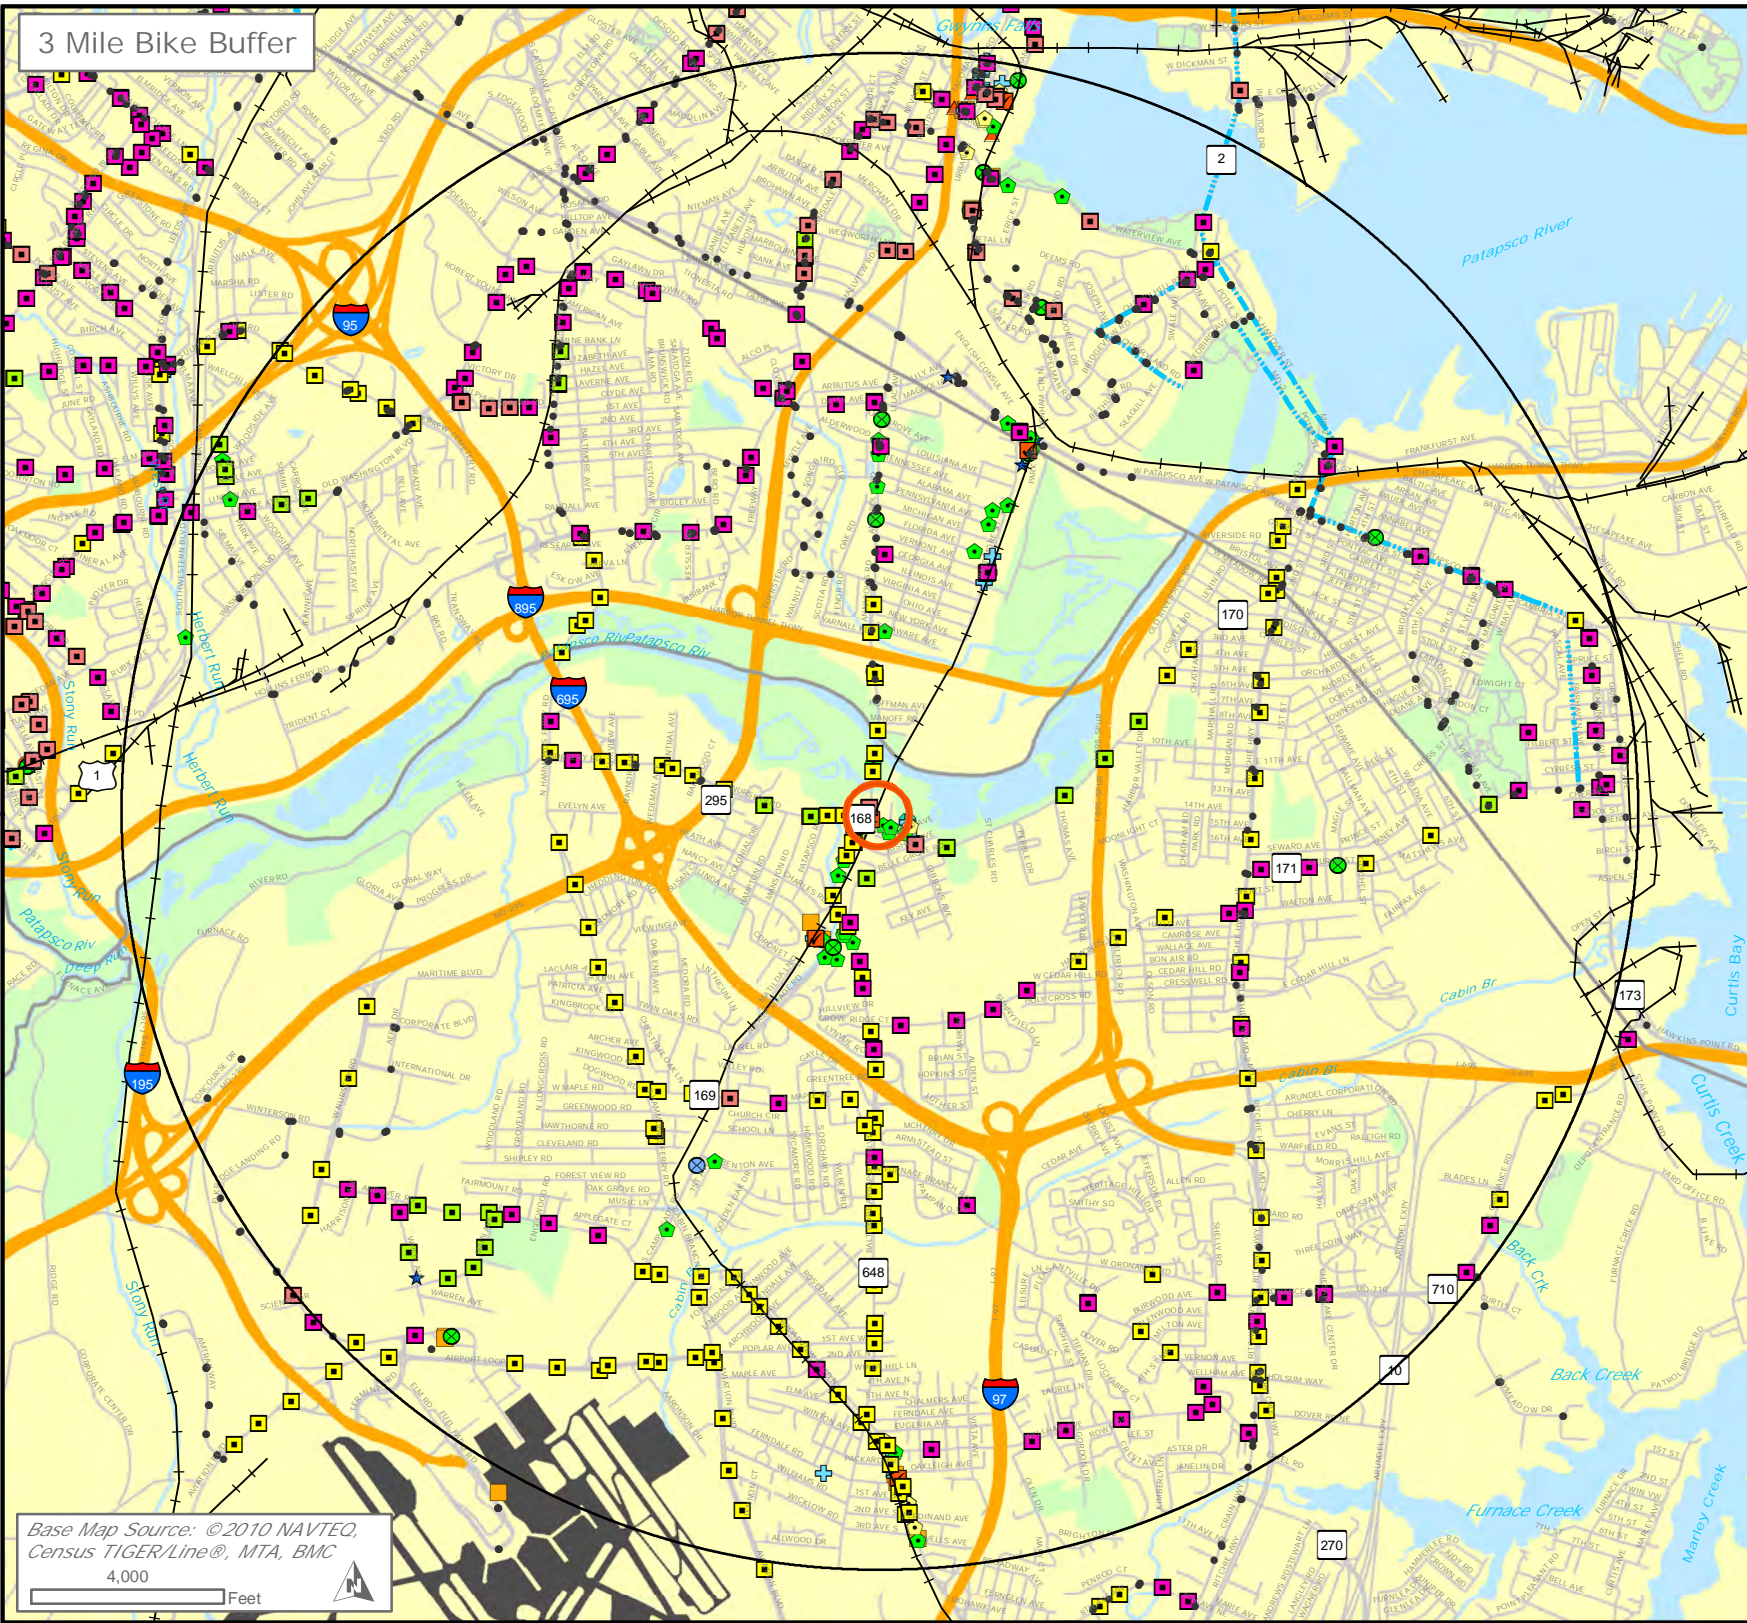
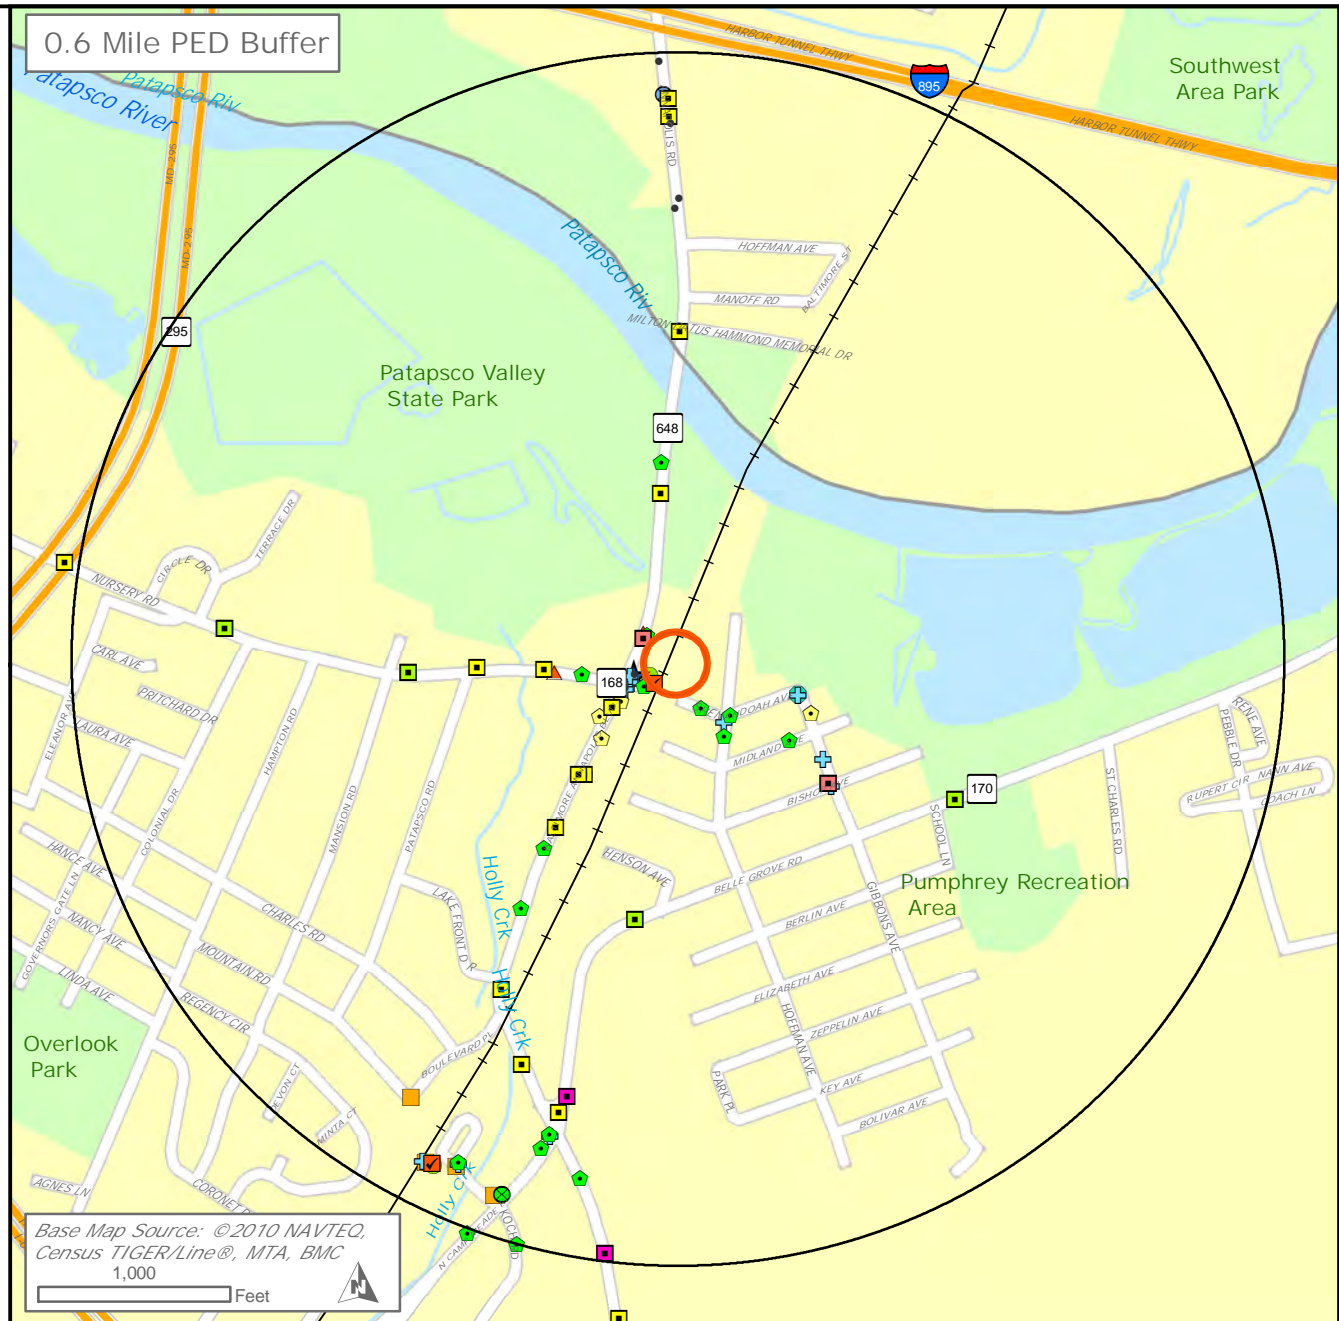
Existing Conditions

The station lacks connectivity to the communities north and west. South of Nursery Road, Baltimore Annapolis Boulevard has sidewalks on both sides, although they are narrow and damaged in many places with need of general maintenance and upkeep. The sidewalk terminates at the intersection of Nursery Road and does not extend north of the station. This leaves a small residential community without any pedestrian access to the station. This section has wide shoulders on both sides and people were observed walking on the shoulder.

- Sidewalks are missing along several roads including Nursery Road, Old Annapolis Road and Hoffman Ave.,
- A crosswalk is recommended for Baltimore Annapolis Blvd @ Nursery Road, Berlin @ Gibbons and Gibbons @ Shenandoah Ave.
- Street Lighting is recommended for the bus stop at B&A Boulevard @ Nursery Road

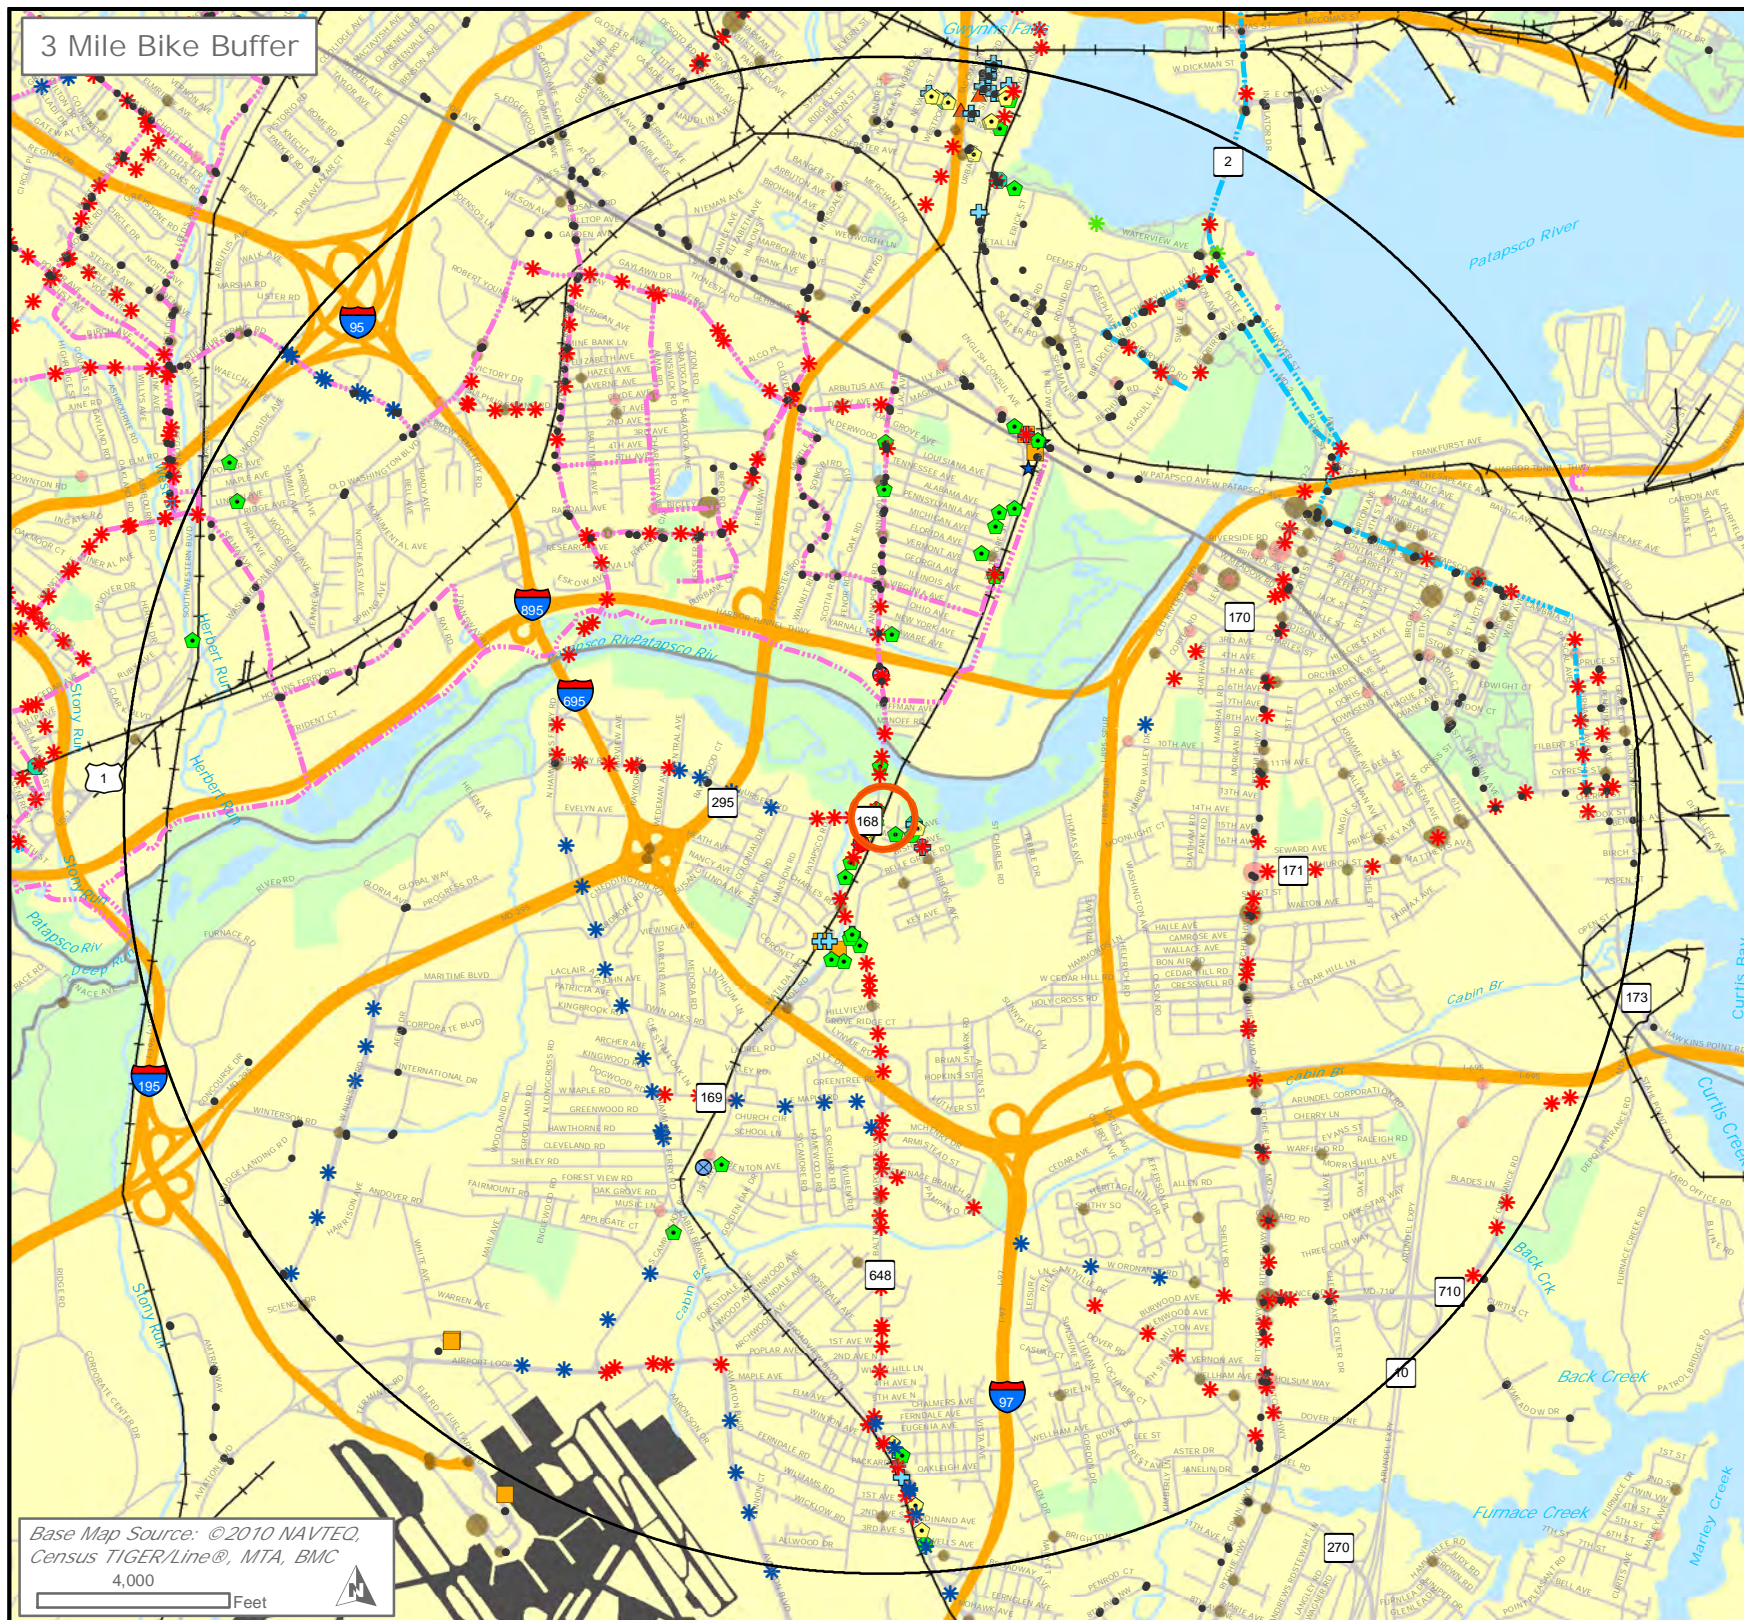
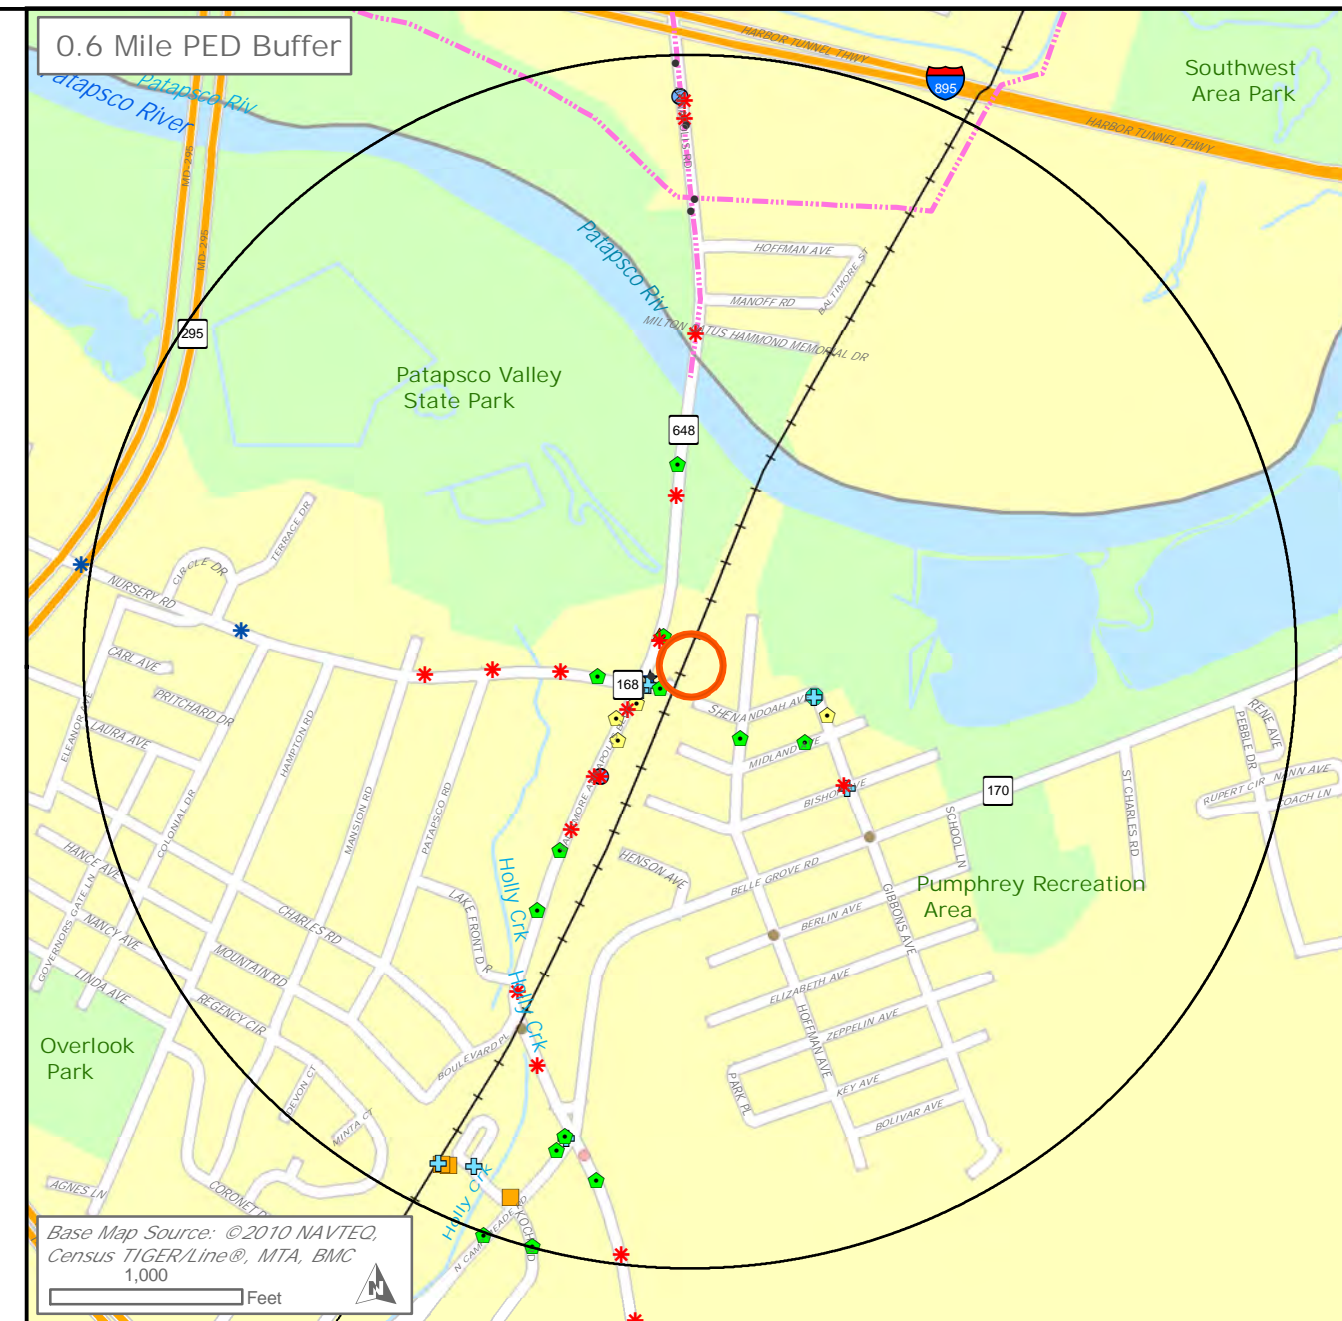
## Recommended Improvements

- On Nursery Road from Wedeman Ave to Colonial Drive, signage is needed to designate shoulder use by bicycles.
- To accommodate shared use lanes on a long portion of Hammonds Ferry Road signage and marking are recommended. For other roads including Hollins Ferry, MD 648, and Nursery Road signage and marking are also recommended.
- Bicycle compatible drainage is needed along Gibbons Ave, and portions of MD 648.
