RAIL LINE: Light Rail

STATION PROFILE: Patapsco

For more detailed information refer to the project database.

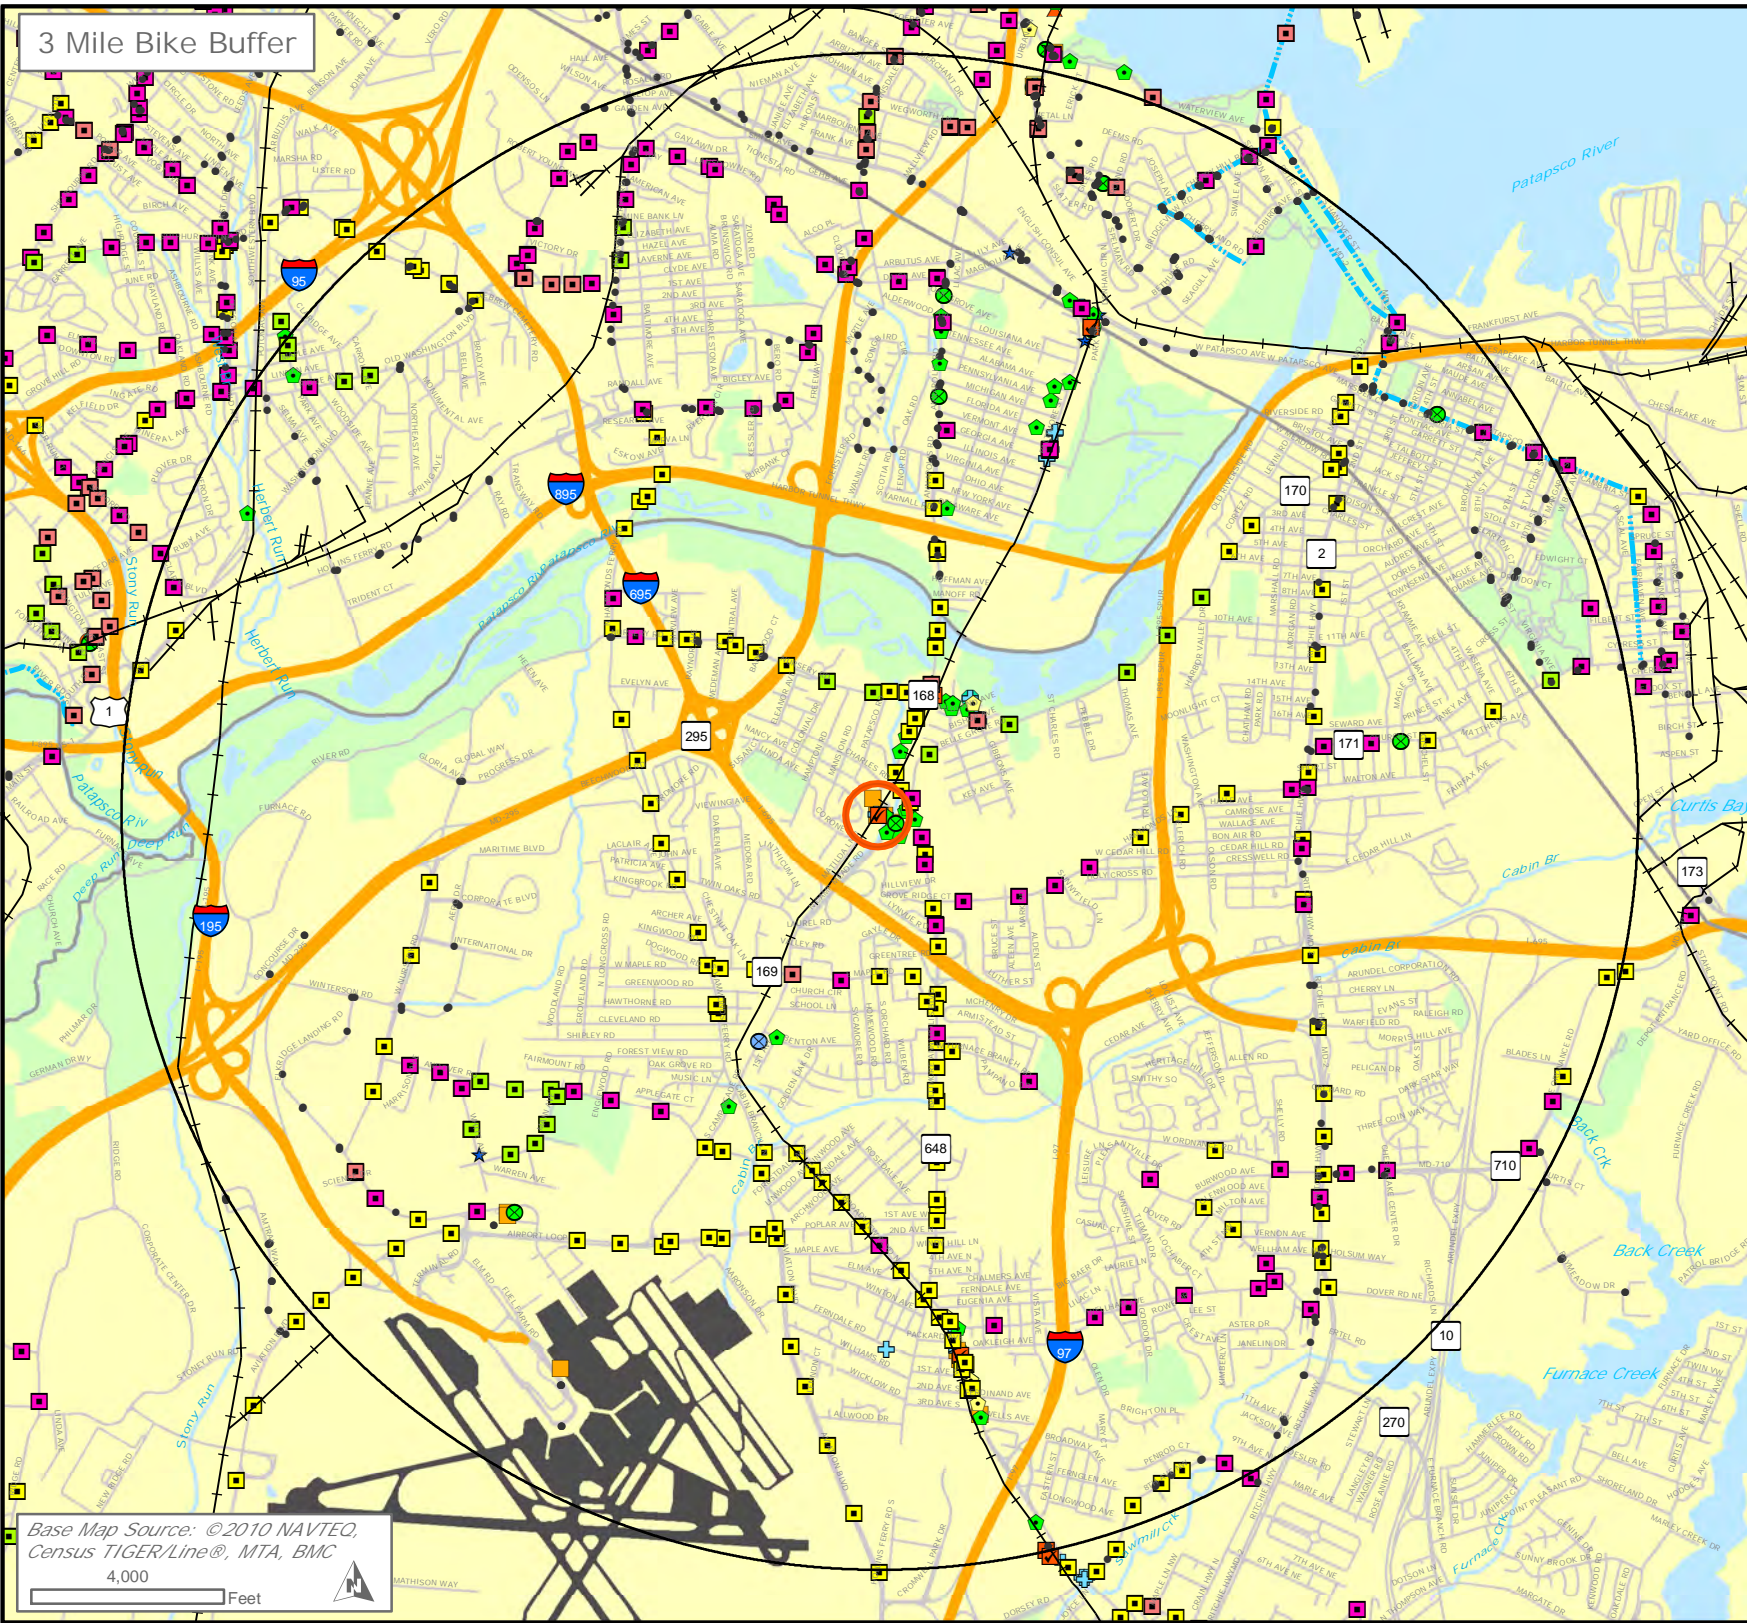
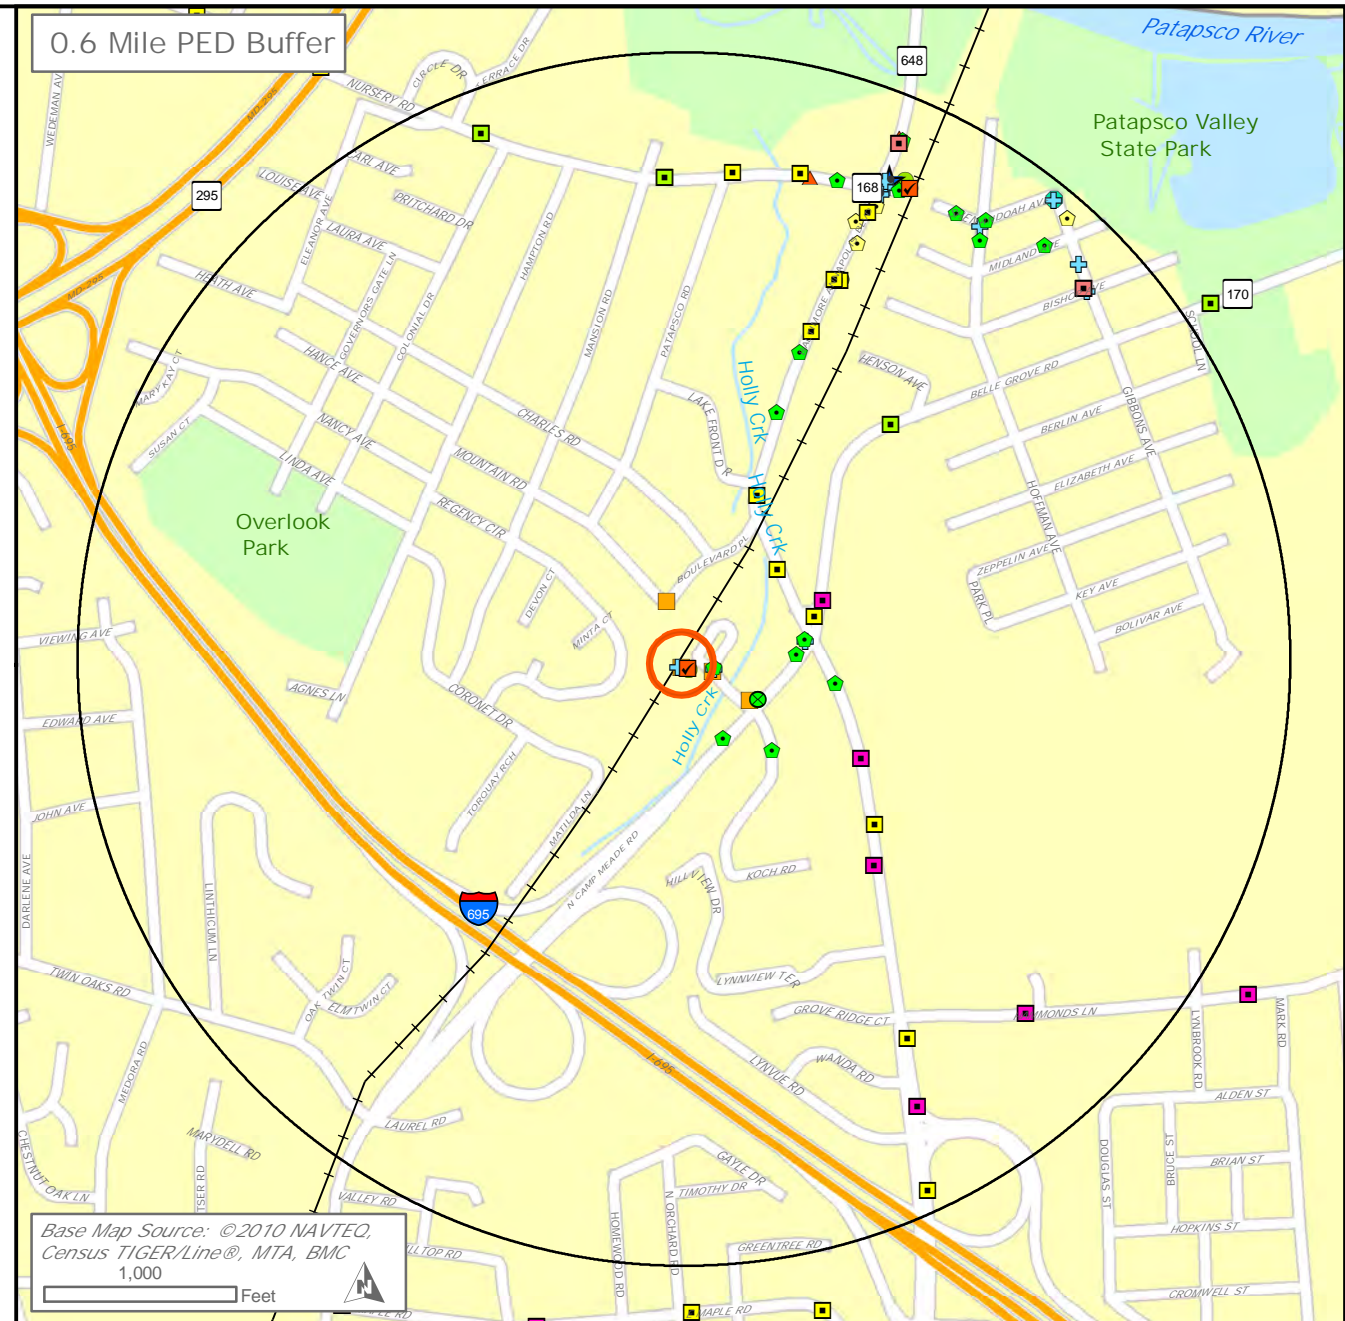
Existing Conditions

- There are several gaps in the sidewalk network along state and county roads in the area.
- Faded or missing crosswalks should be replaced within the station to provide designated path for pedestrians. Pedestrian crossing signs should be placed at the railroad crossing.
- Crosswalk repainting is needed at Camp Meade Road @ B&A Boulevard.

- To support shoulder use along MD 170 from 10th Ave to 6th Avenue bicycle signage is recommended.
- Restriping, signing and marking are recommended for MD 170 from 6th to Potee to support shared use lanes.
- Bicycle signage and some marking is recommended for segments of MD 171, Route 2 and MD 648.

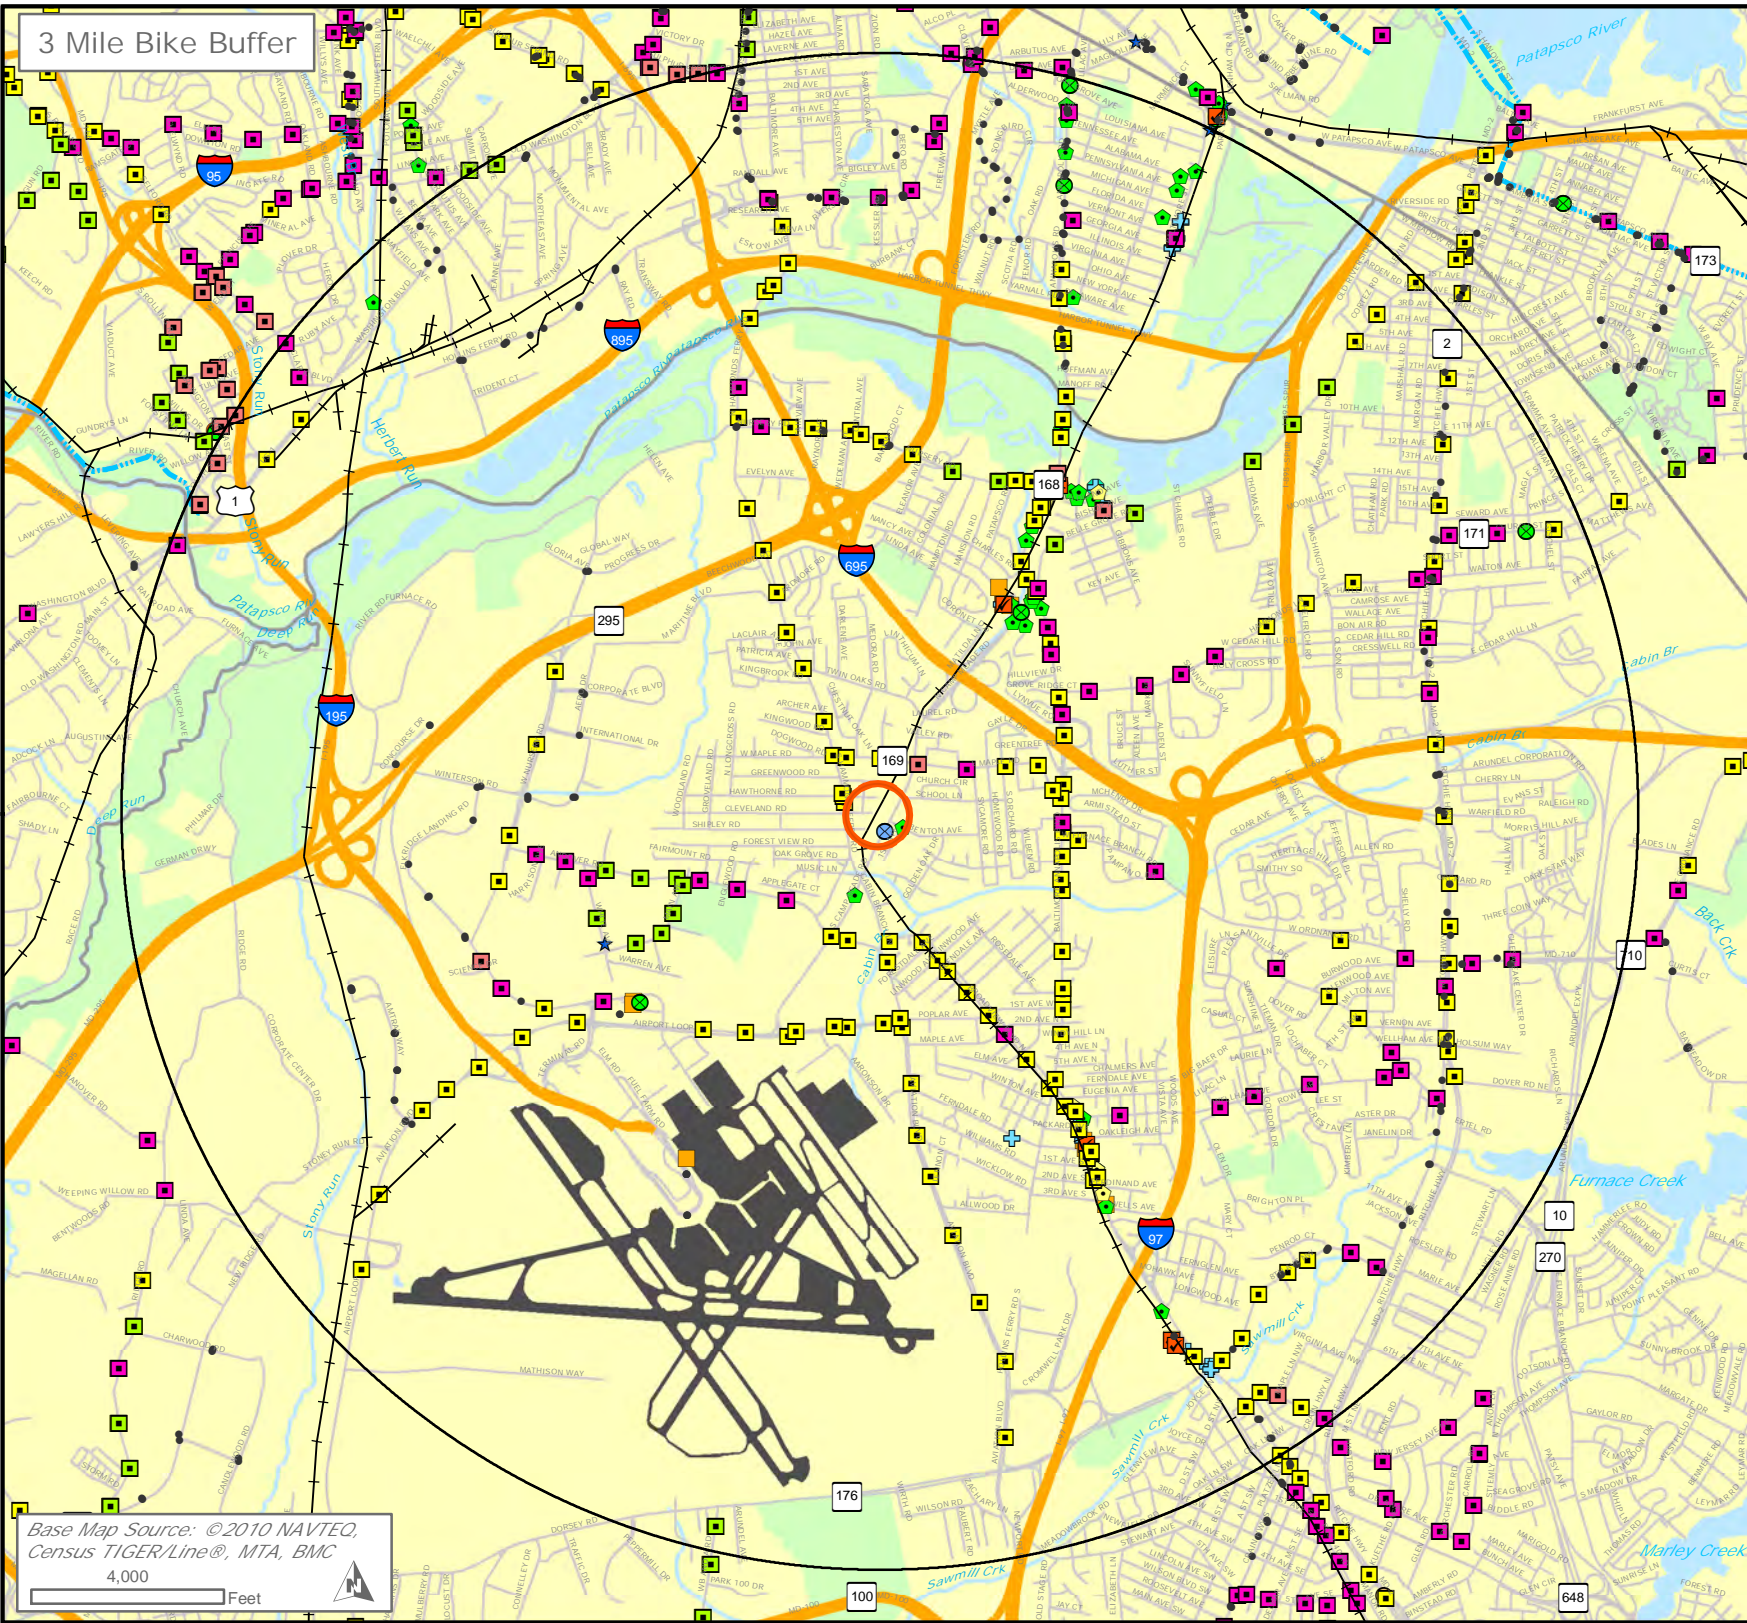
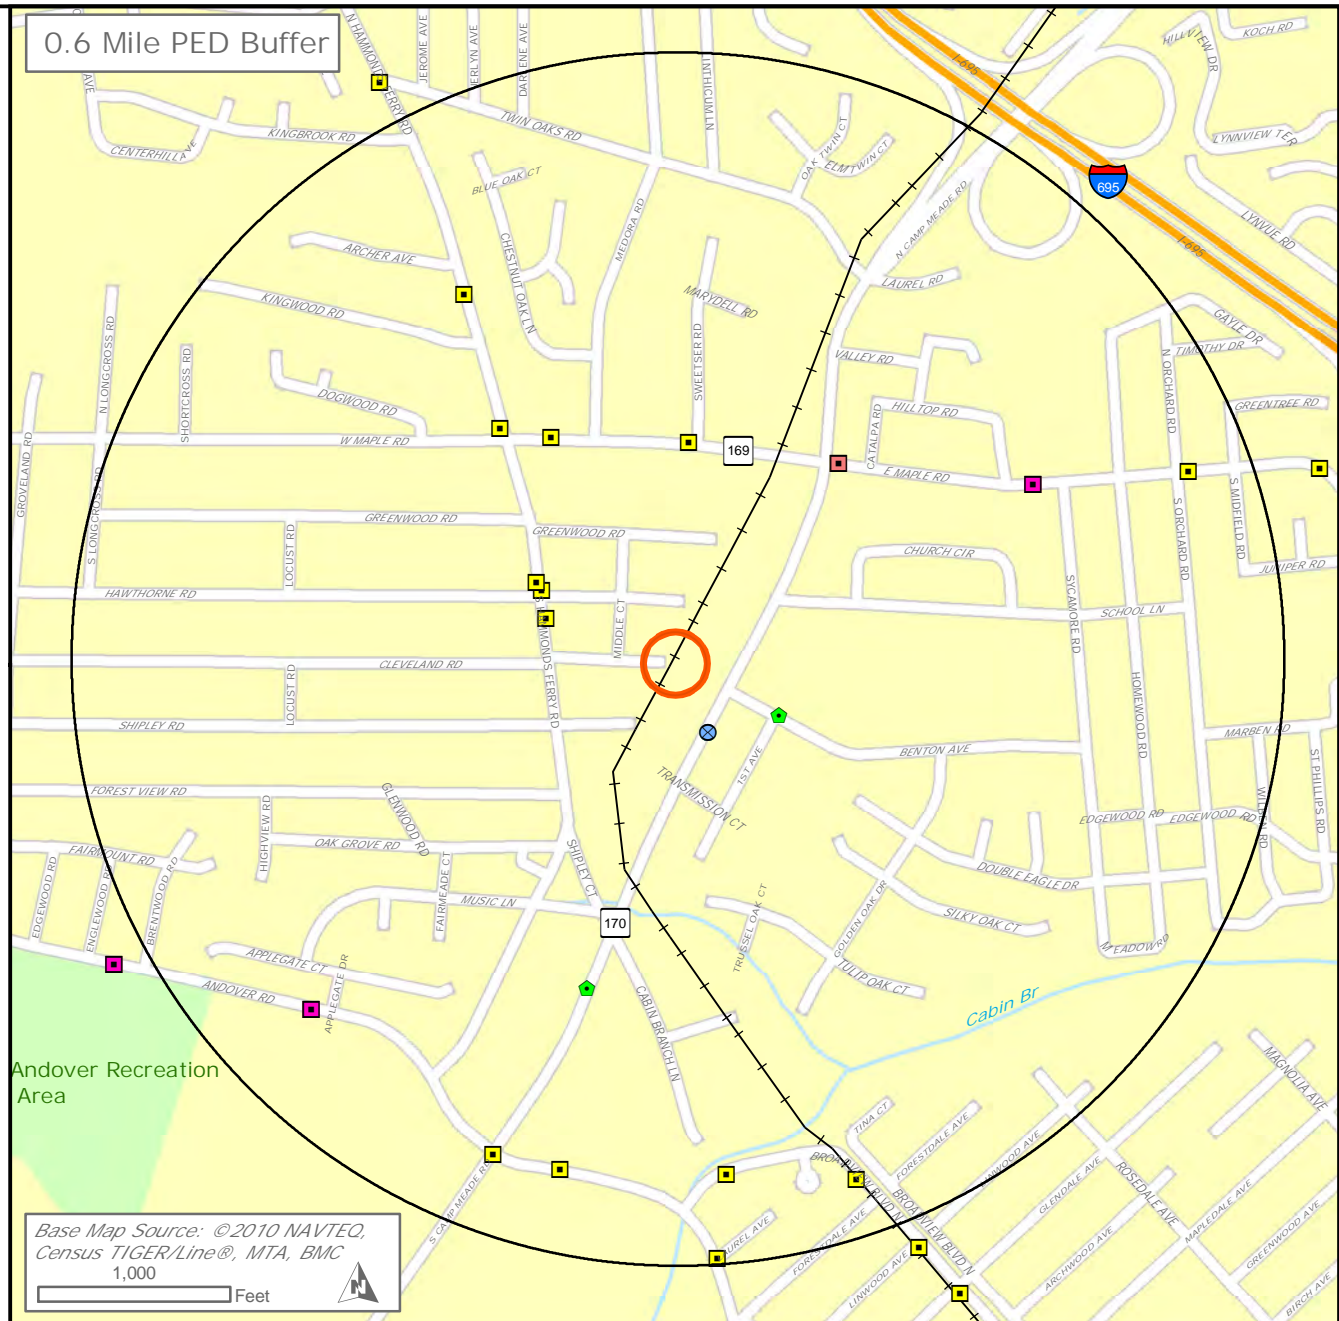
Existing Conditions

- A few short segments of missing sidewalk should be provided.
- Wayfinding signage is recommended on Camp Meade Road.

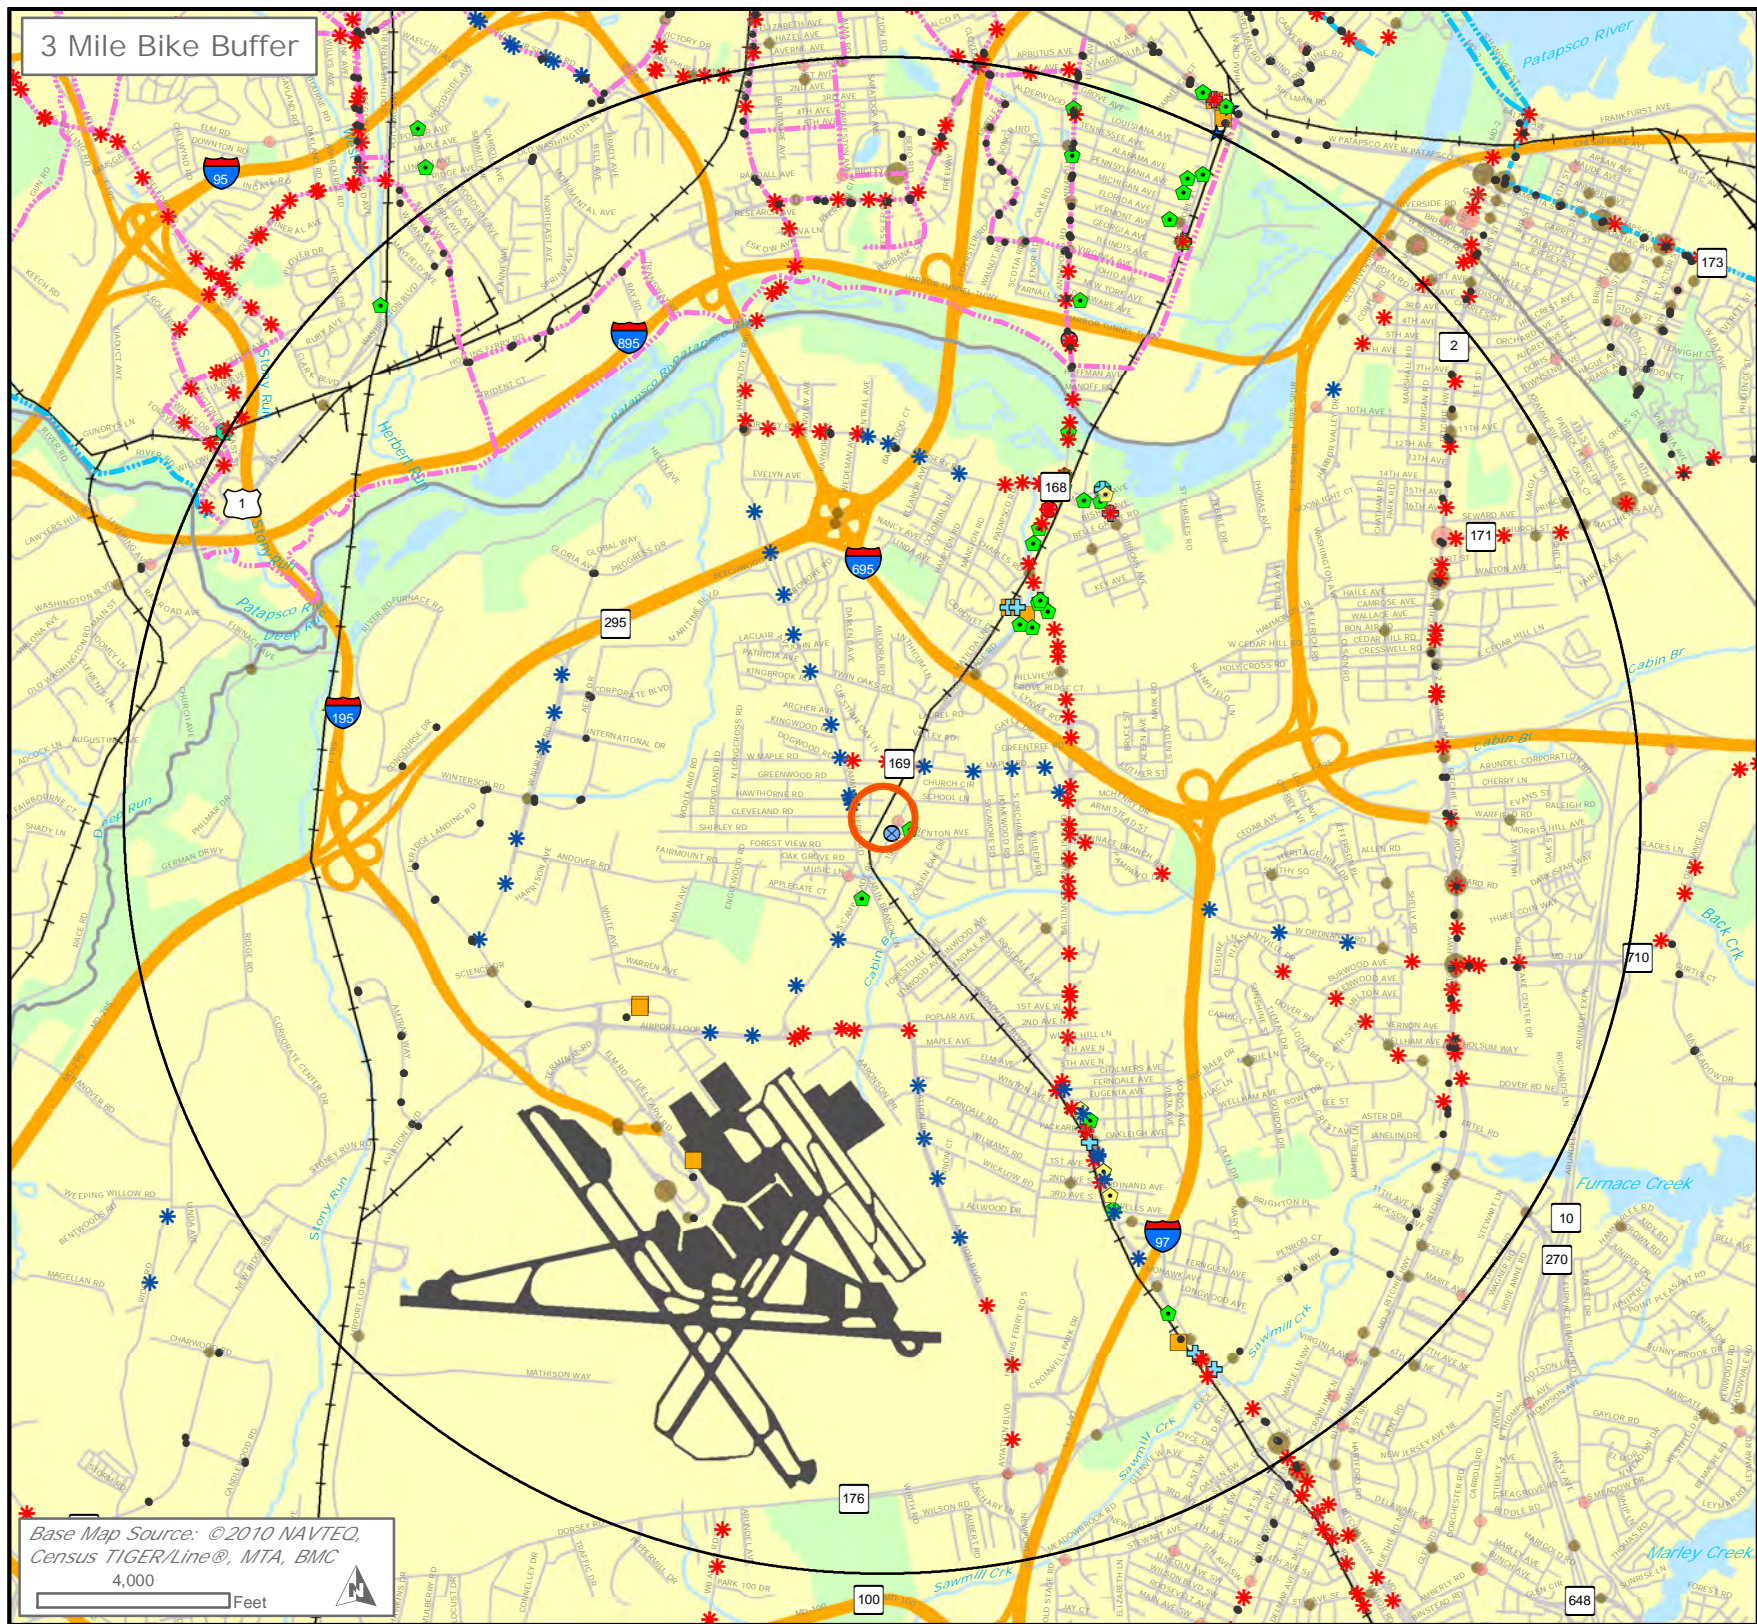
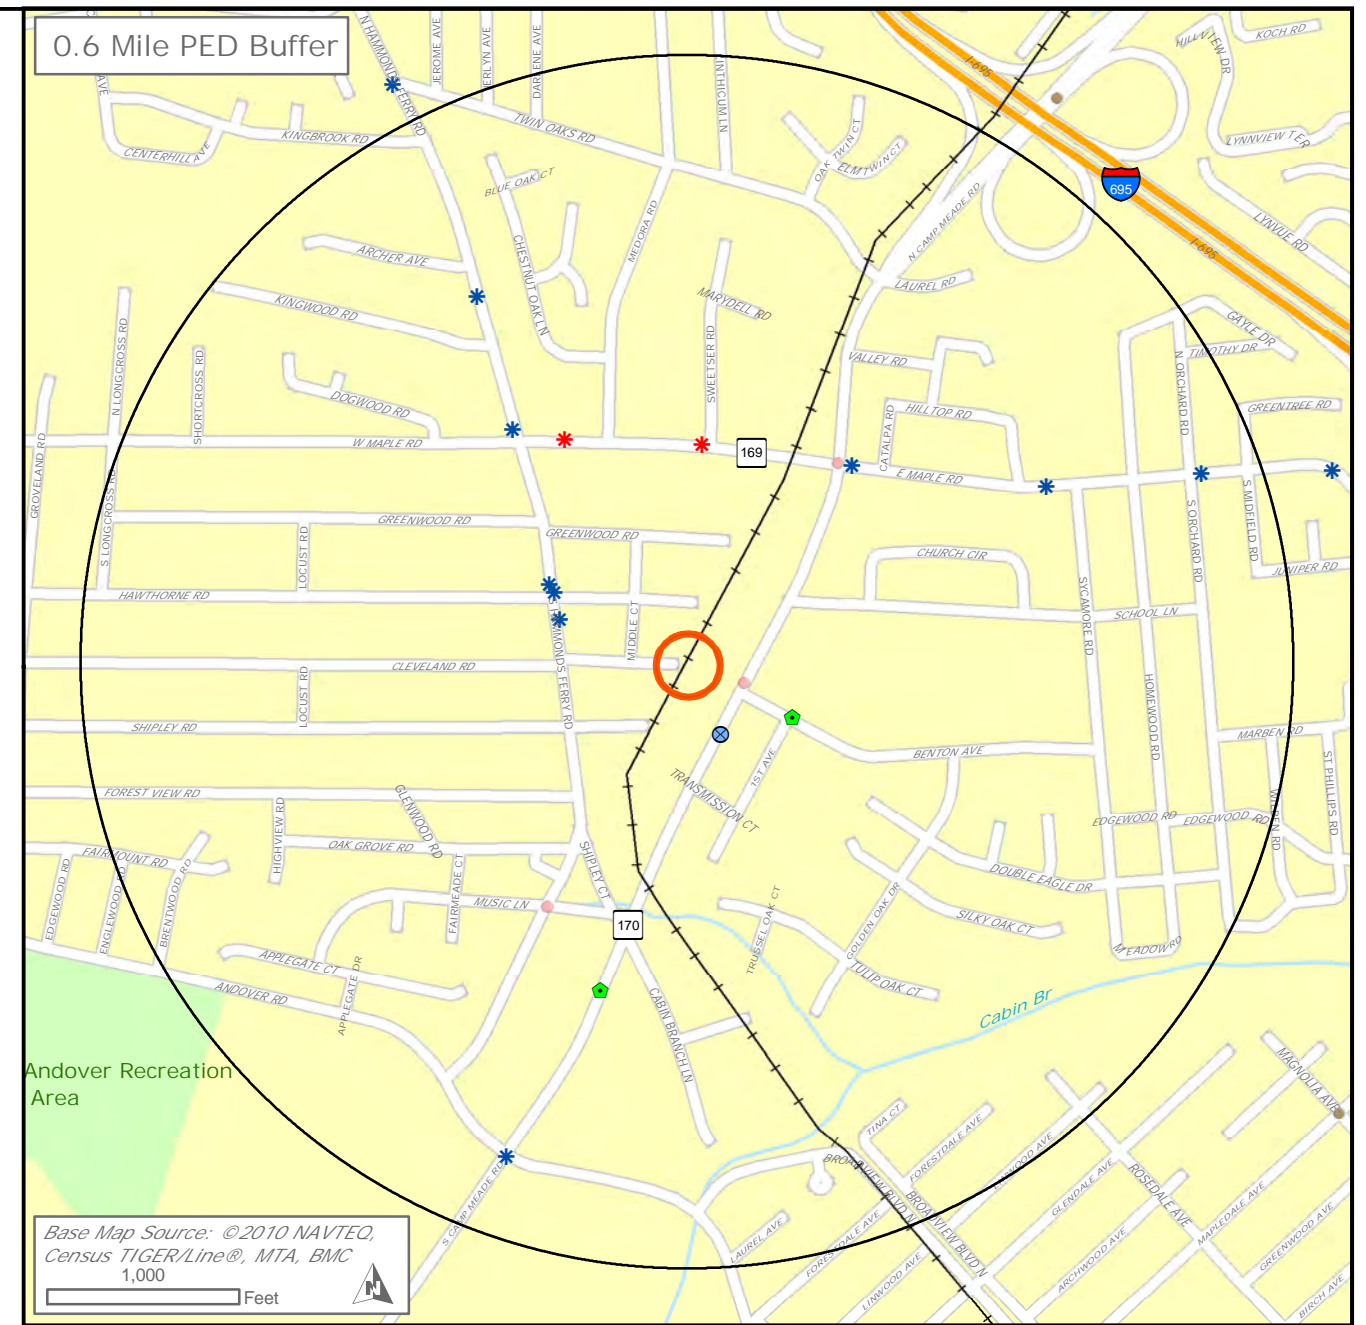
## Recommended Improvements

- To support shoulder use along MD 170 from 10th Ave to 6th Avenue bicycle signage is recommended.
- Restriping, signing and marking are recommended for MD 170 from 6th to Potee to support shared use lanes.
- Bicycle signage, and some marking is recommended for segments of MD 171, Route 2 and MD 648.

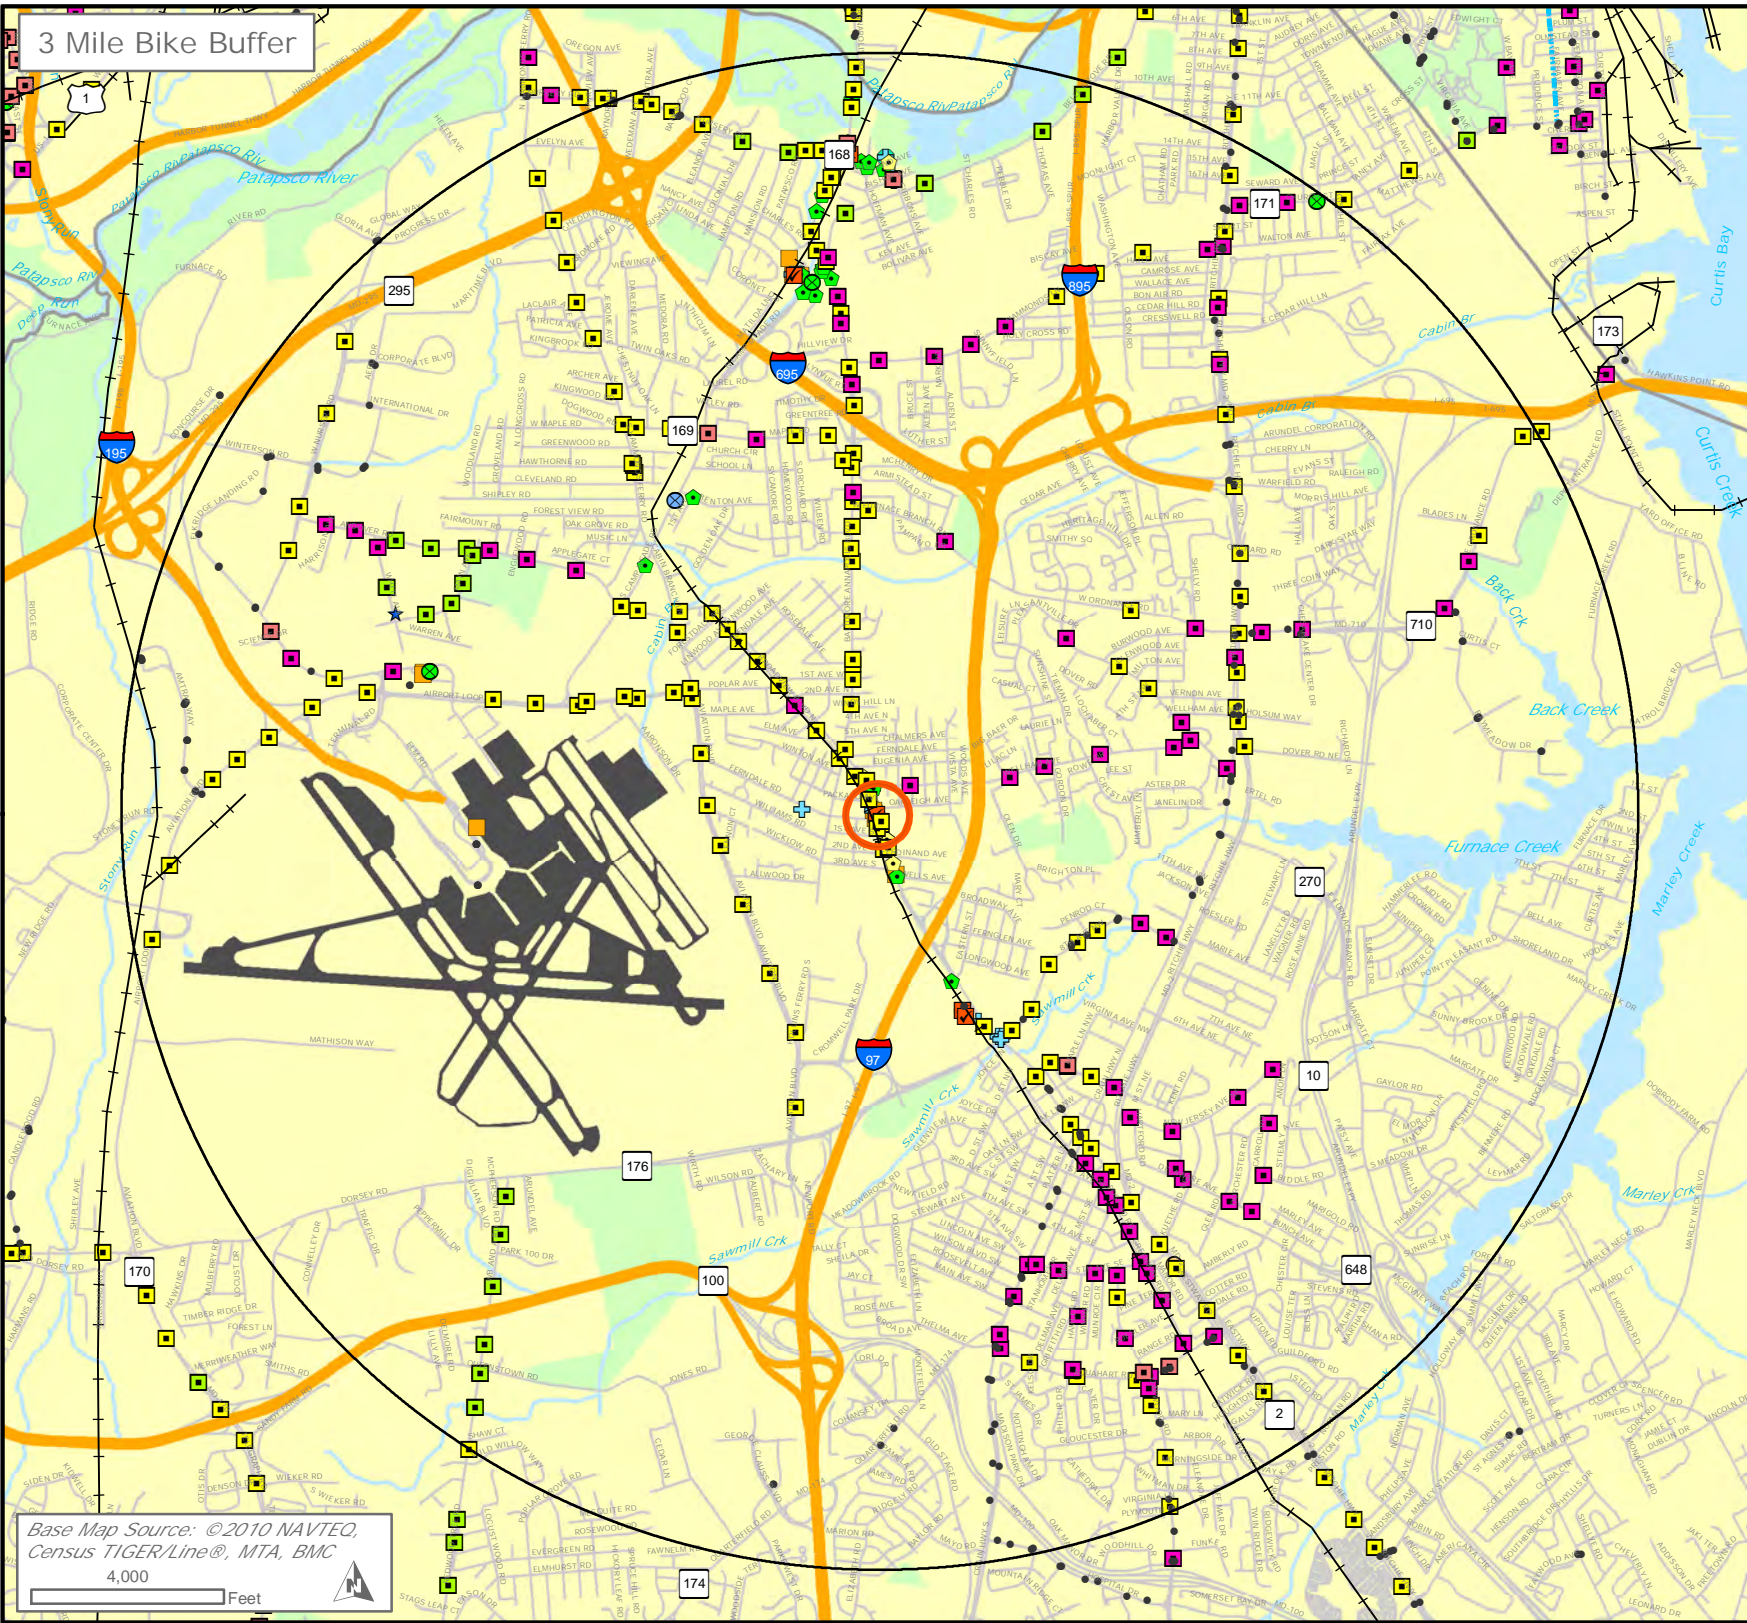
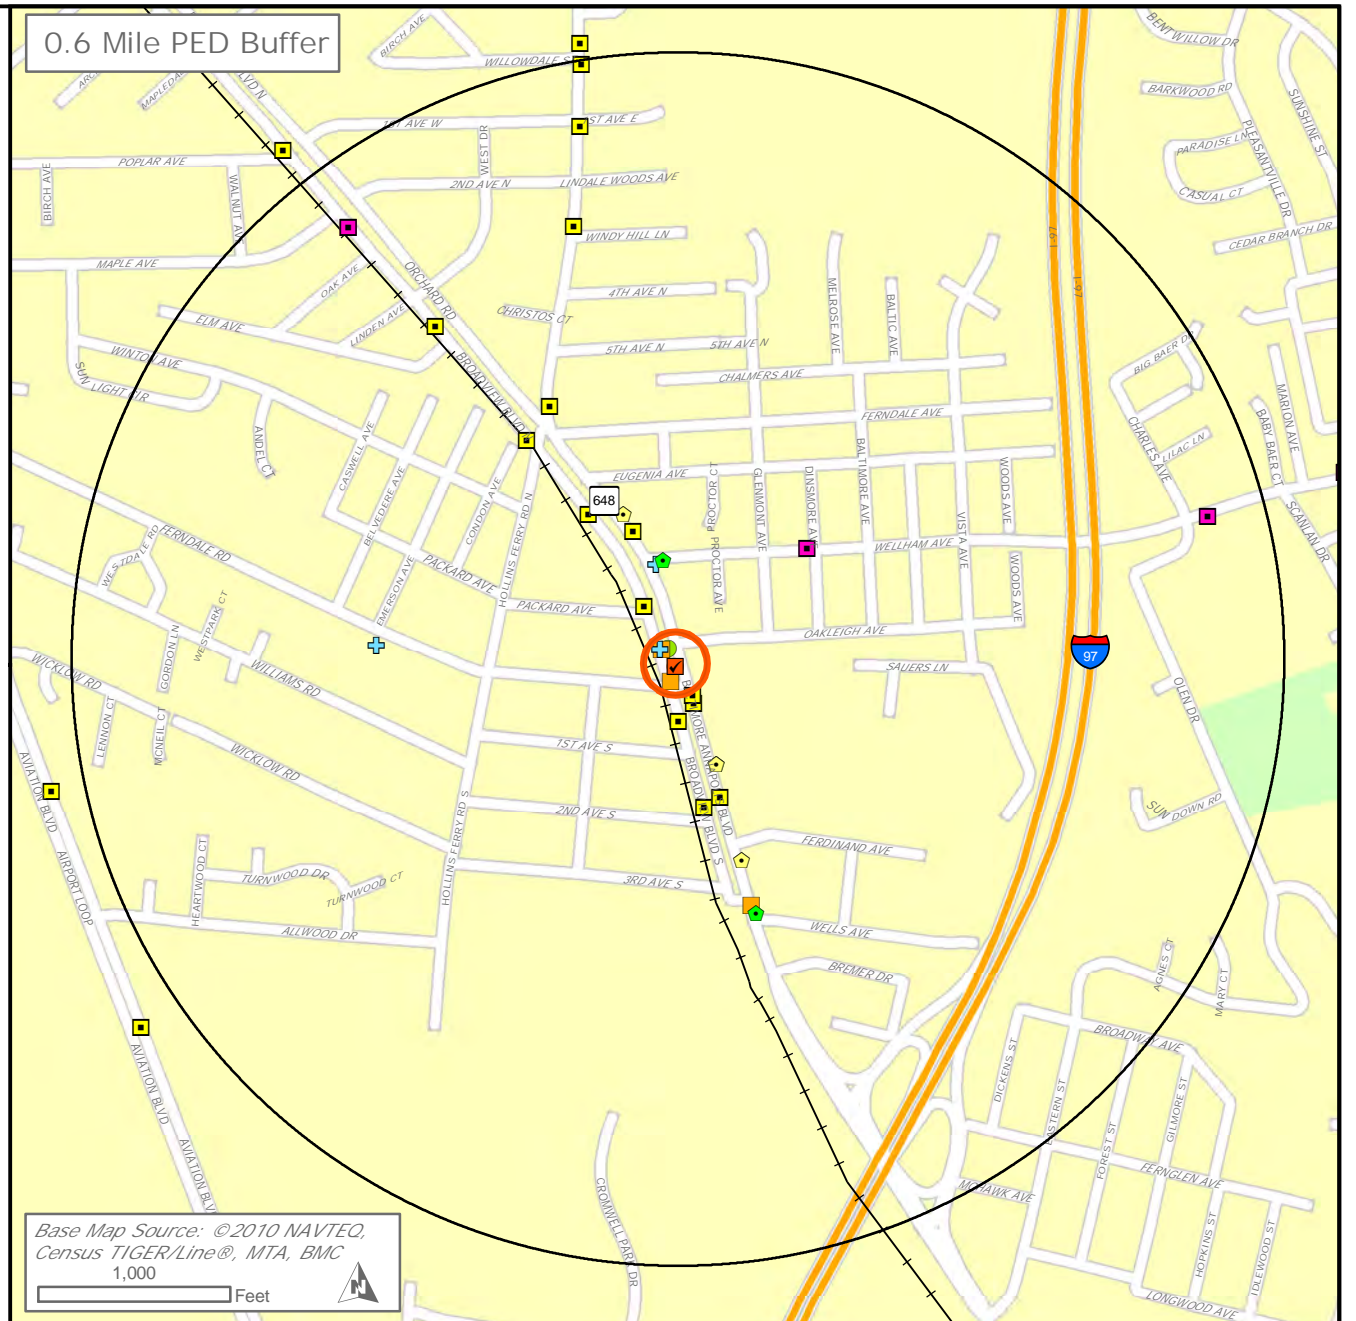
Existing Conditions

- There are segments of missing or damaged sidewalk along B&A Boulevard that should be replaced. A tree also needs to be removed along B&A Boulevard.

- Bicycle signage and marking is needed to support shoulder use along MD 648 and MD 710.
- Share the Road signage and marking is recommended to accommodate shared use lanes along several roads including: Broadview Boulevard, MD 2; and West Furnace Branch Road.
