RAIL LINE: Light Rail

STATION PROFILE: Patapsco

For more detailed information refer to the project database.

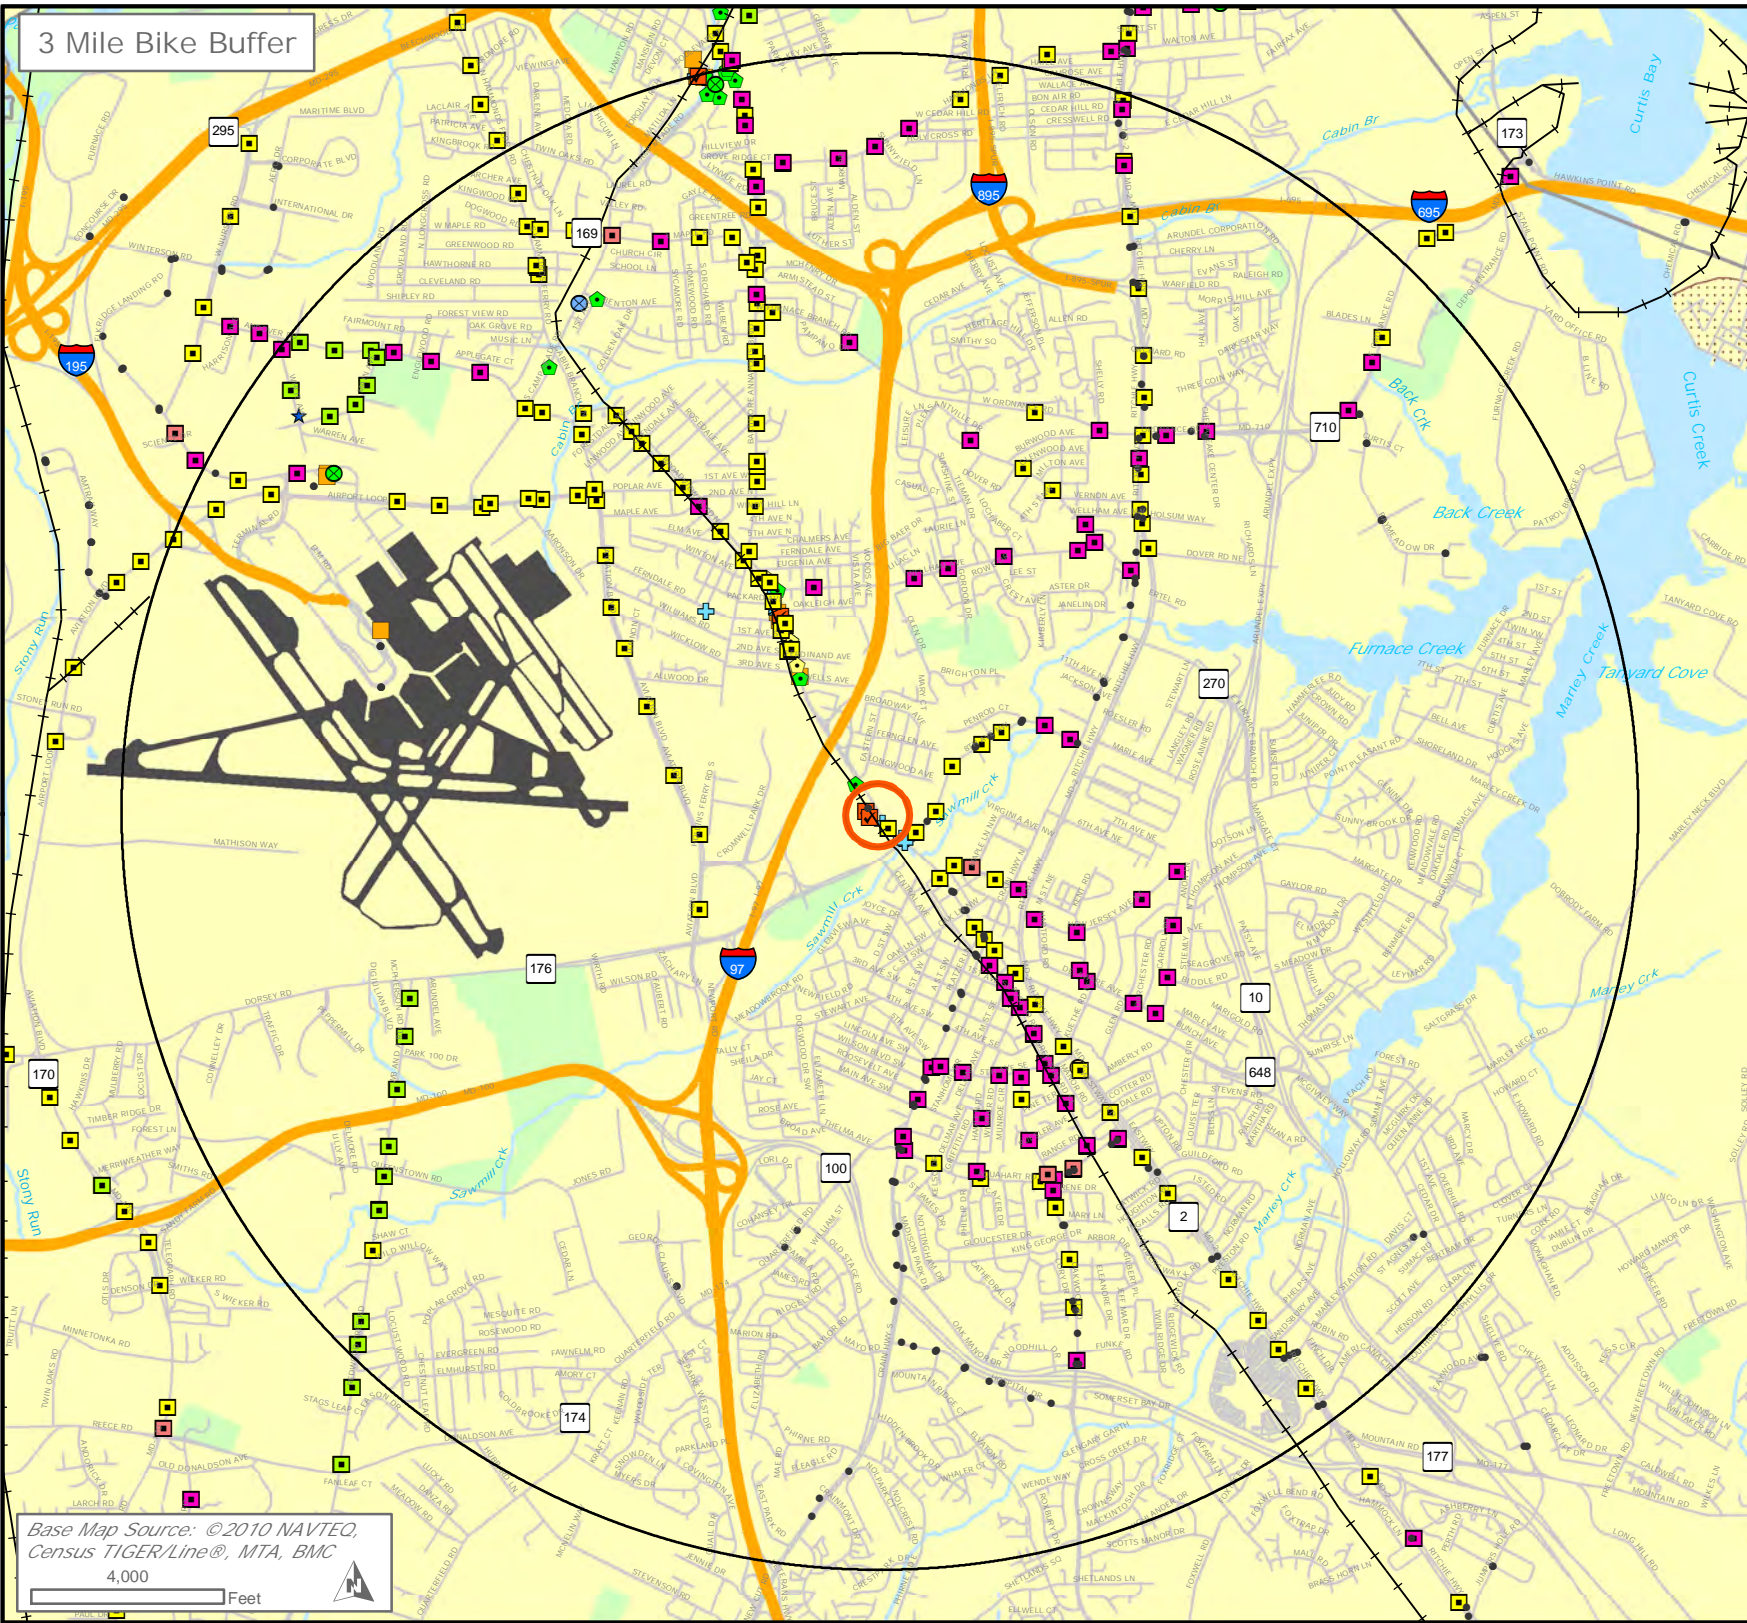
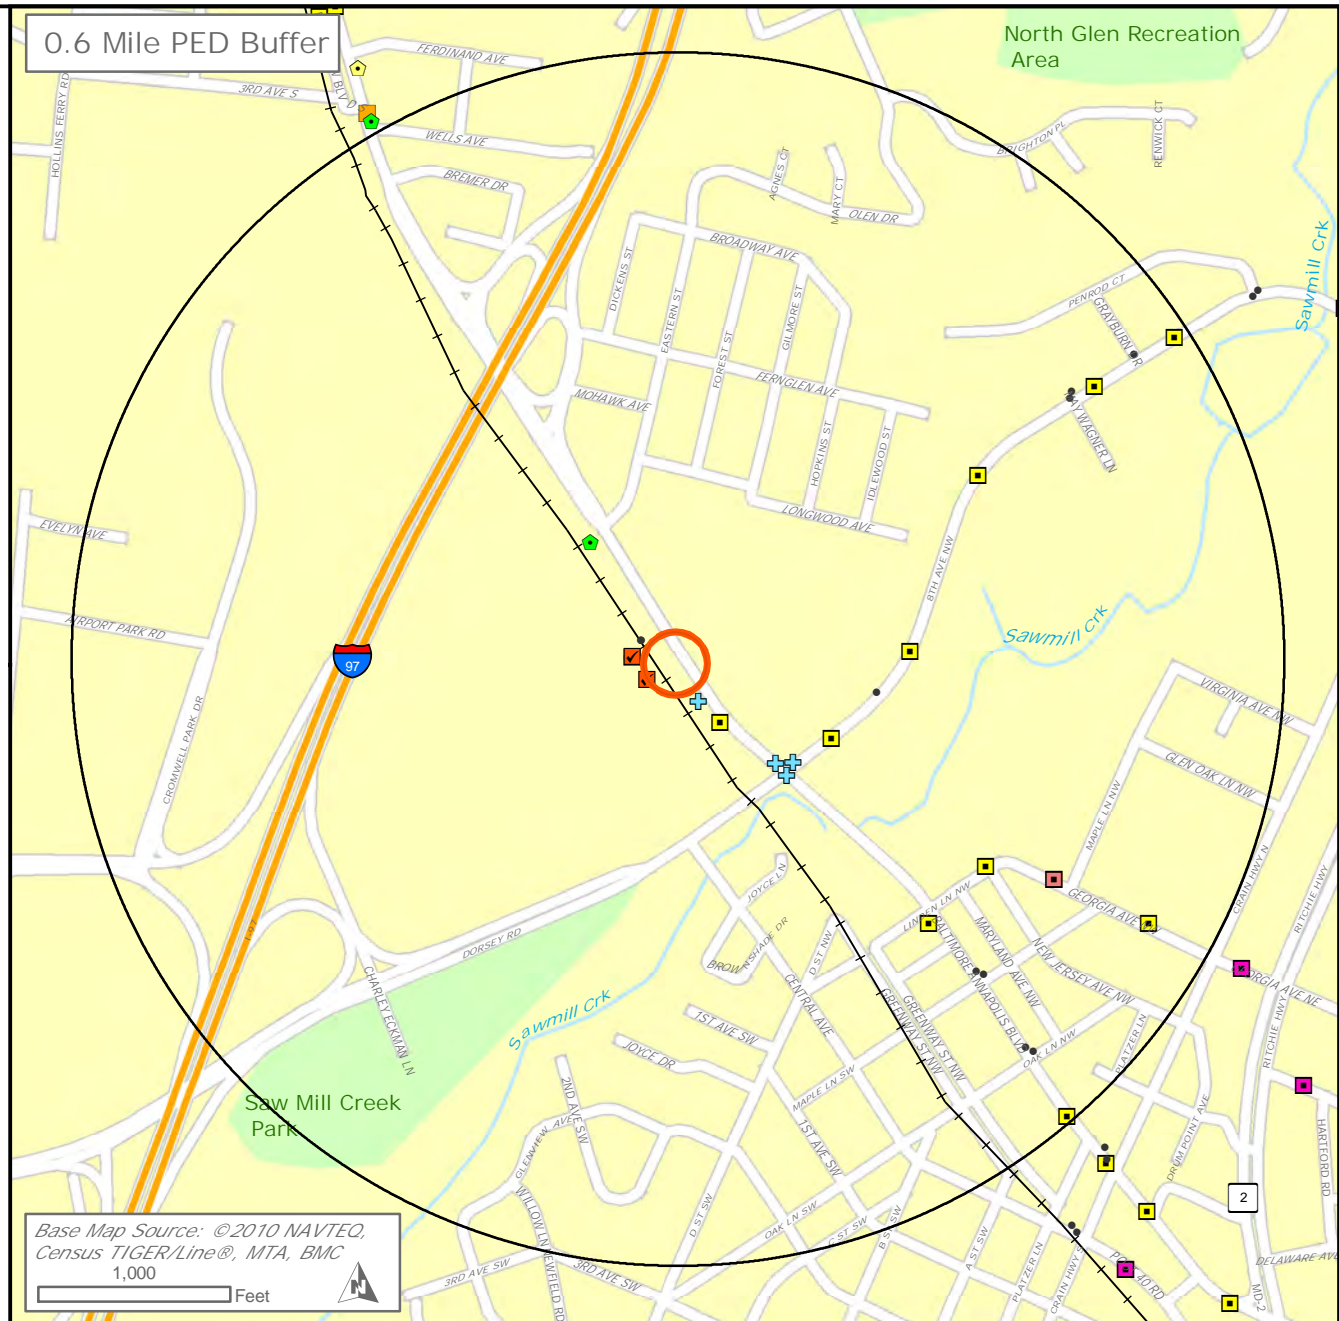
Existing Conditions

Baltimore Annapolis Boulevard is a busy road and has a sidewalk only on one side on a small stretch of road adjacent to the station. Even though there are signalized pedestrian crossings at both station entrances, there is no connecting sidewalk on the other side of the road. People arriving and leaving the rail station were observed crossing the Boulevard mid-block which is not recommended. Improvements are needed to pedestrian circulation within the station parking lot and driveways. Where a pedestrian path enters the station from the north and crosses the busy access road, a clearly marked pedestrian path was absent. Also a painted crosswalk is missing where ramps lead from the station to the parking lot. The sidewalk on B&A Boulevard to the south of the station terminates at 8th Avenue.

- Missing sidewalks, crosswalks and pedestrian crossing signs should be provided in the vicinity of the station to help prevent crashes.
- Pedestrian pathways /crosswalks are needed within the station site to create safe areas for pedestrians.
- A pedestrian signal and crosswalk is recommended for the intersection of B&A Boulevard and Dorsey Road.

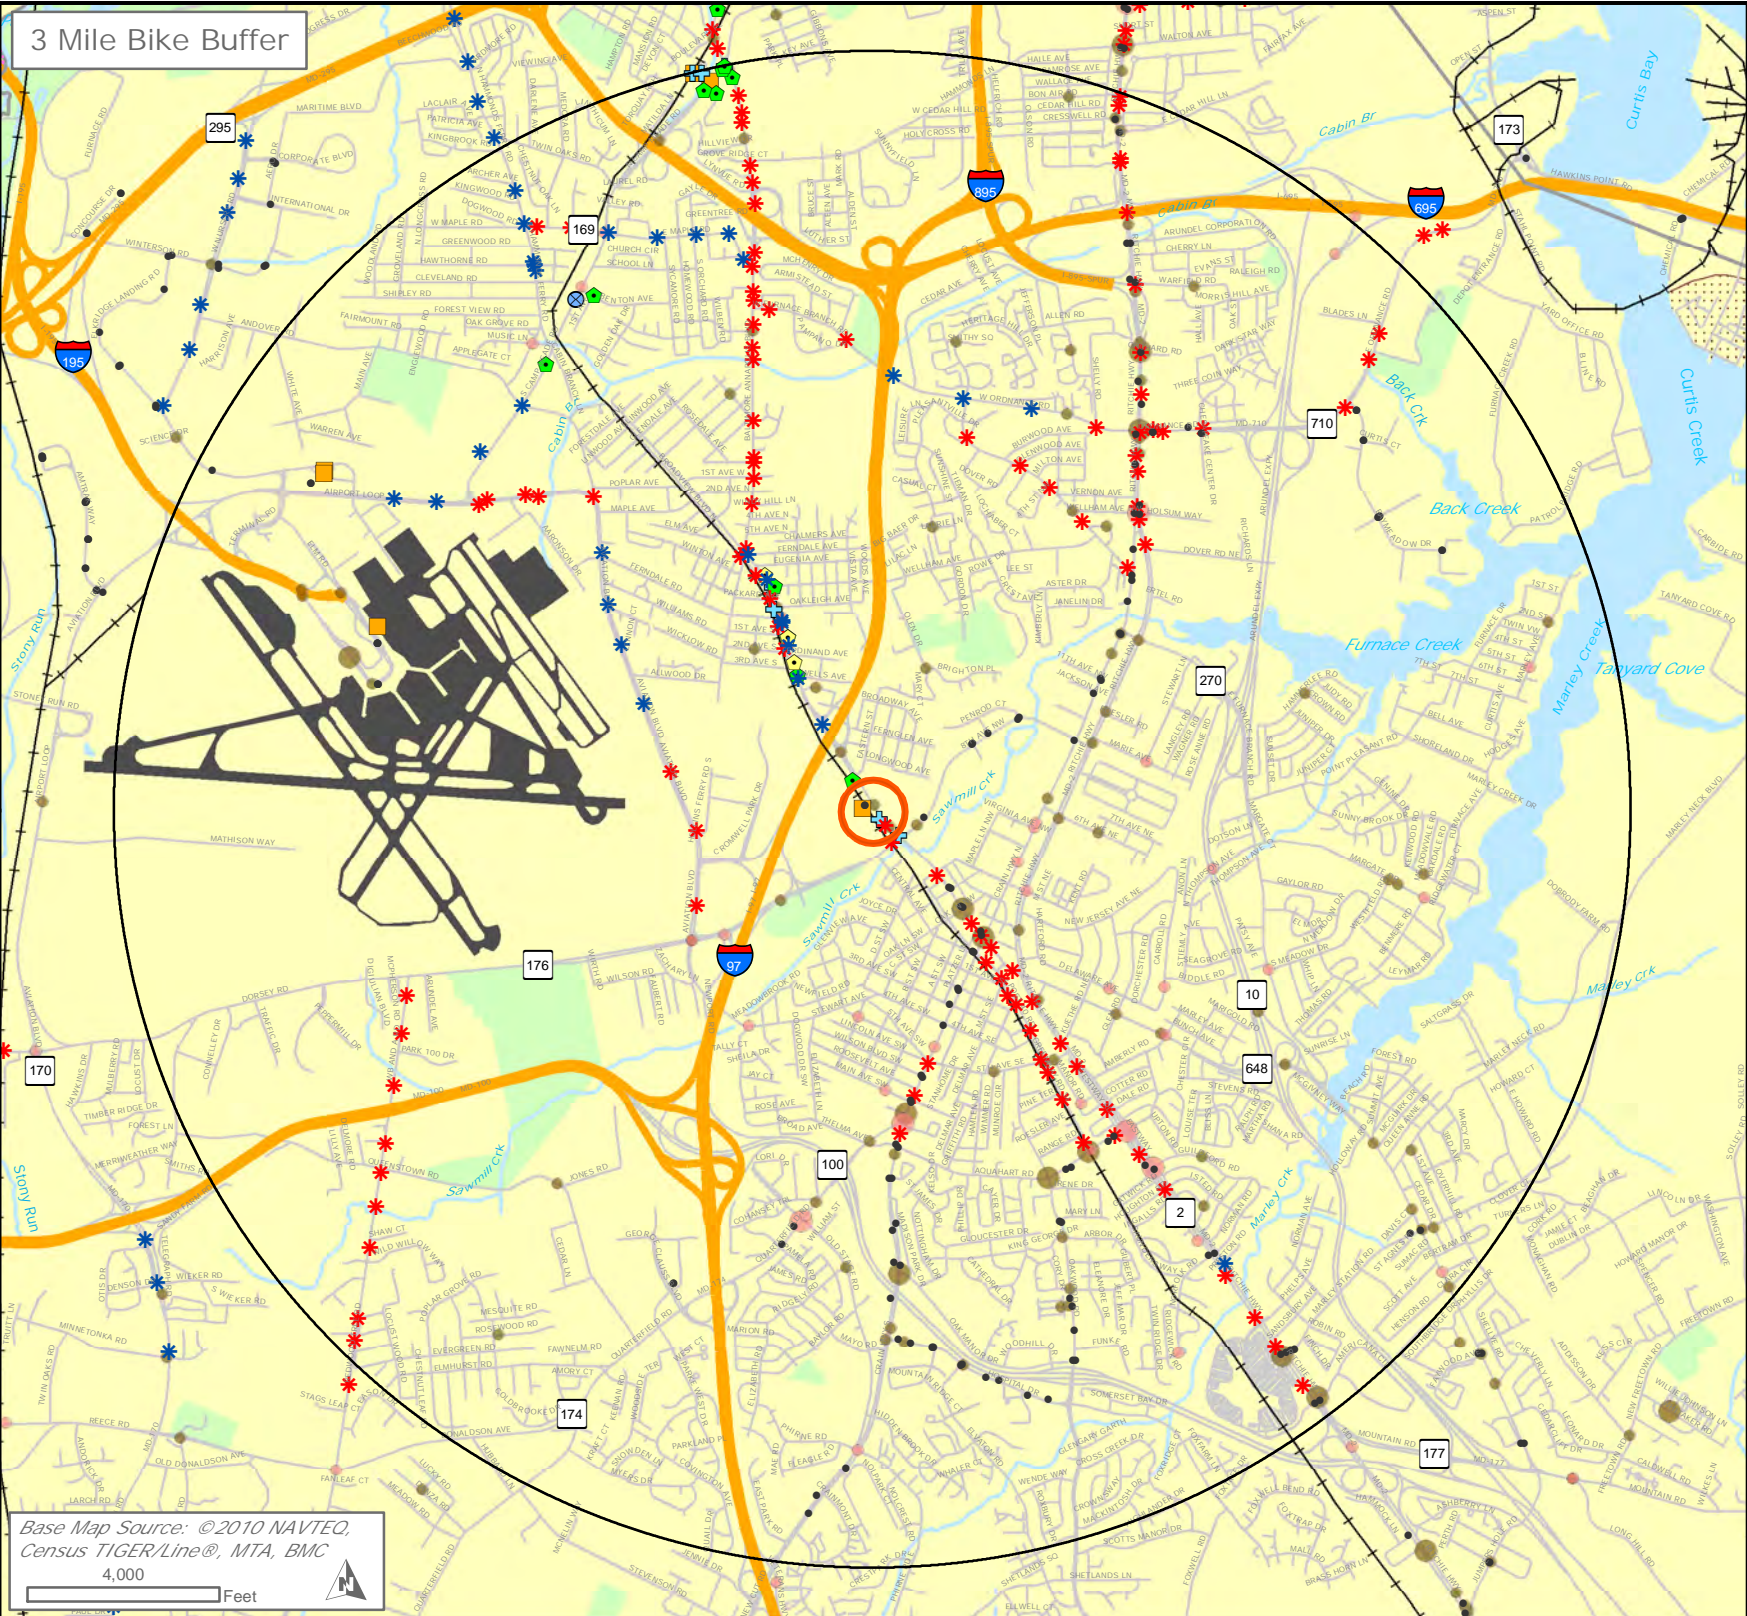
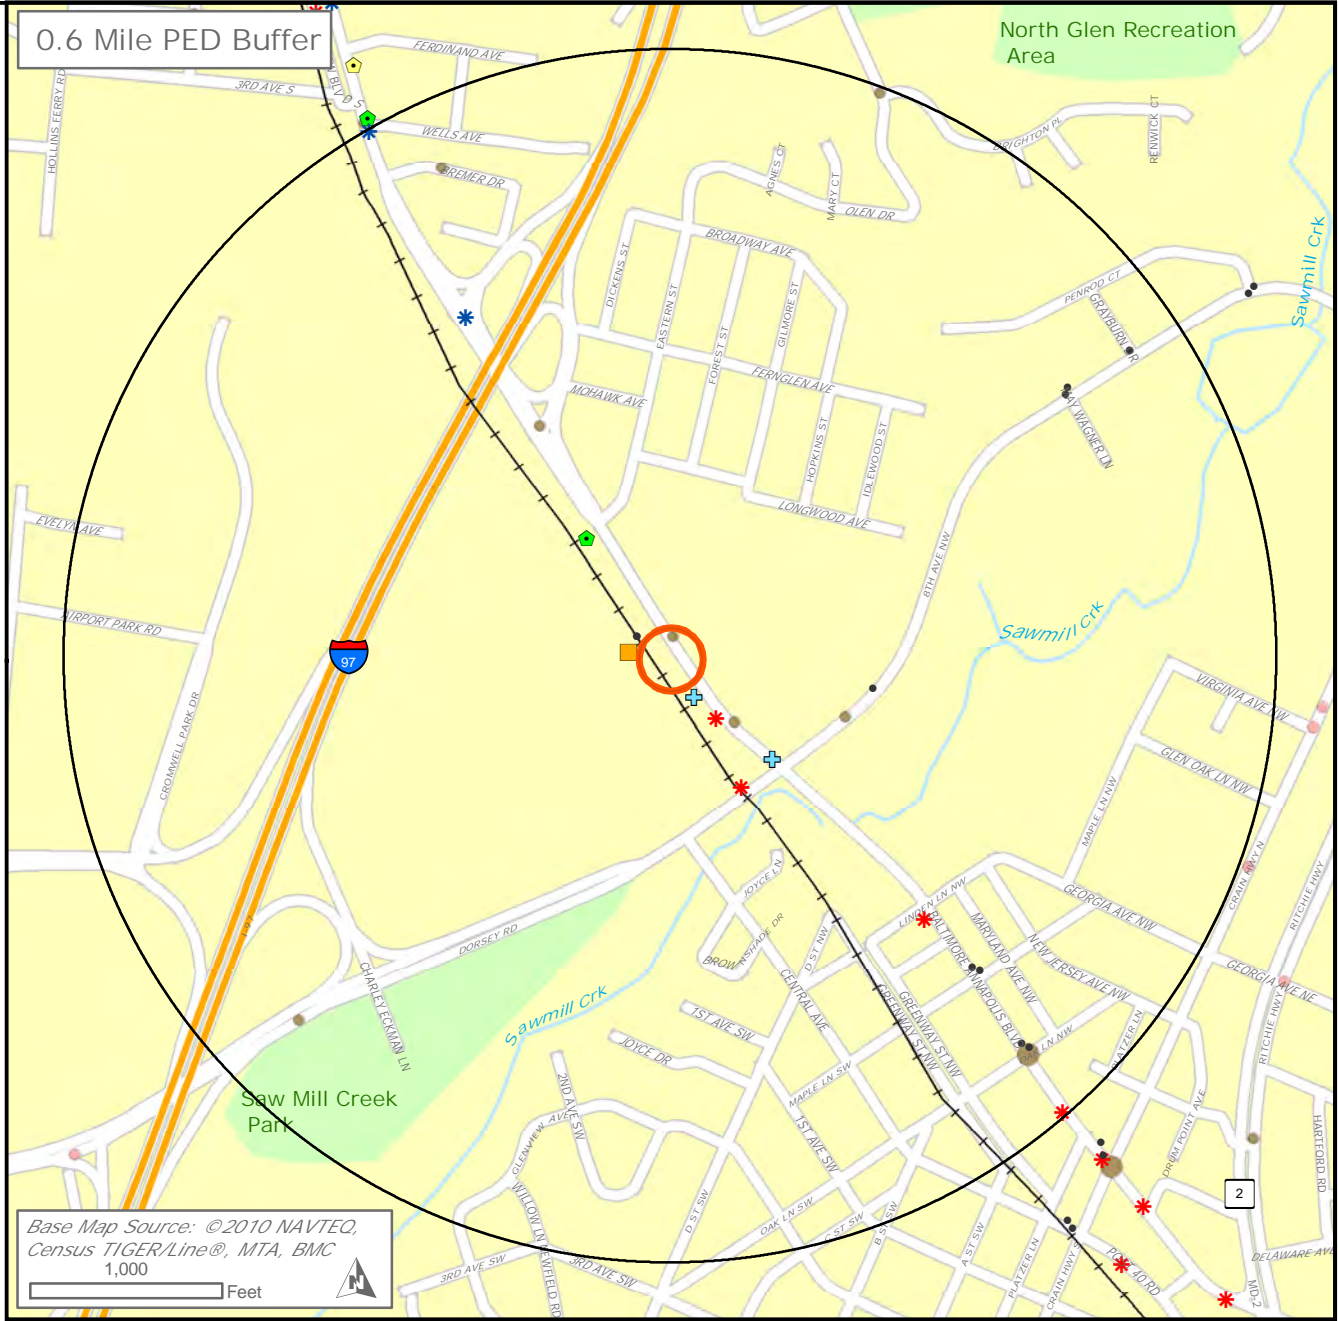
Recommended Improvements

- Bicycle signage is recommended to support shoulder use of MD 162 and Ritchie Highway.
- To support shared use lanes on Aquahart, Greenway, MD 176 and MD 3 bicycle signage and marking is recommended. This may help reduce crashes.

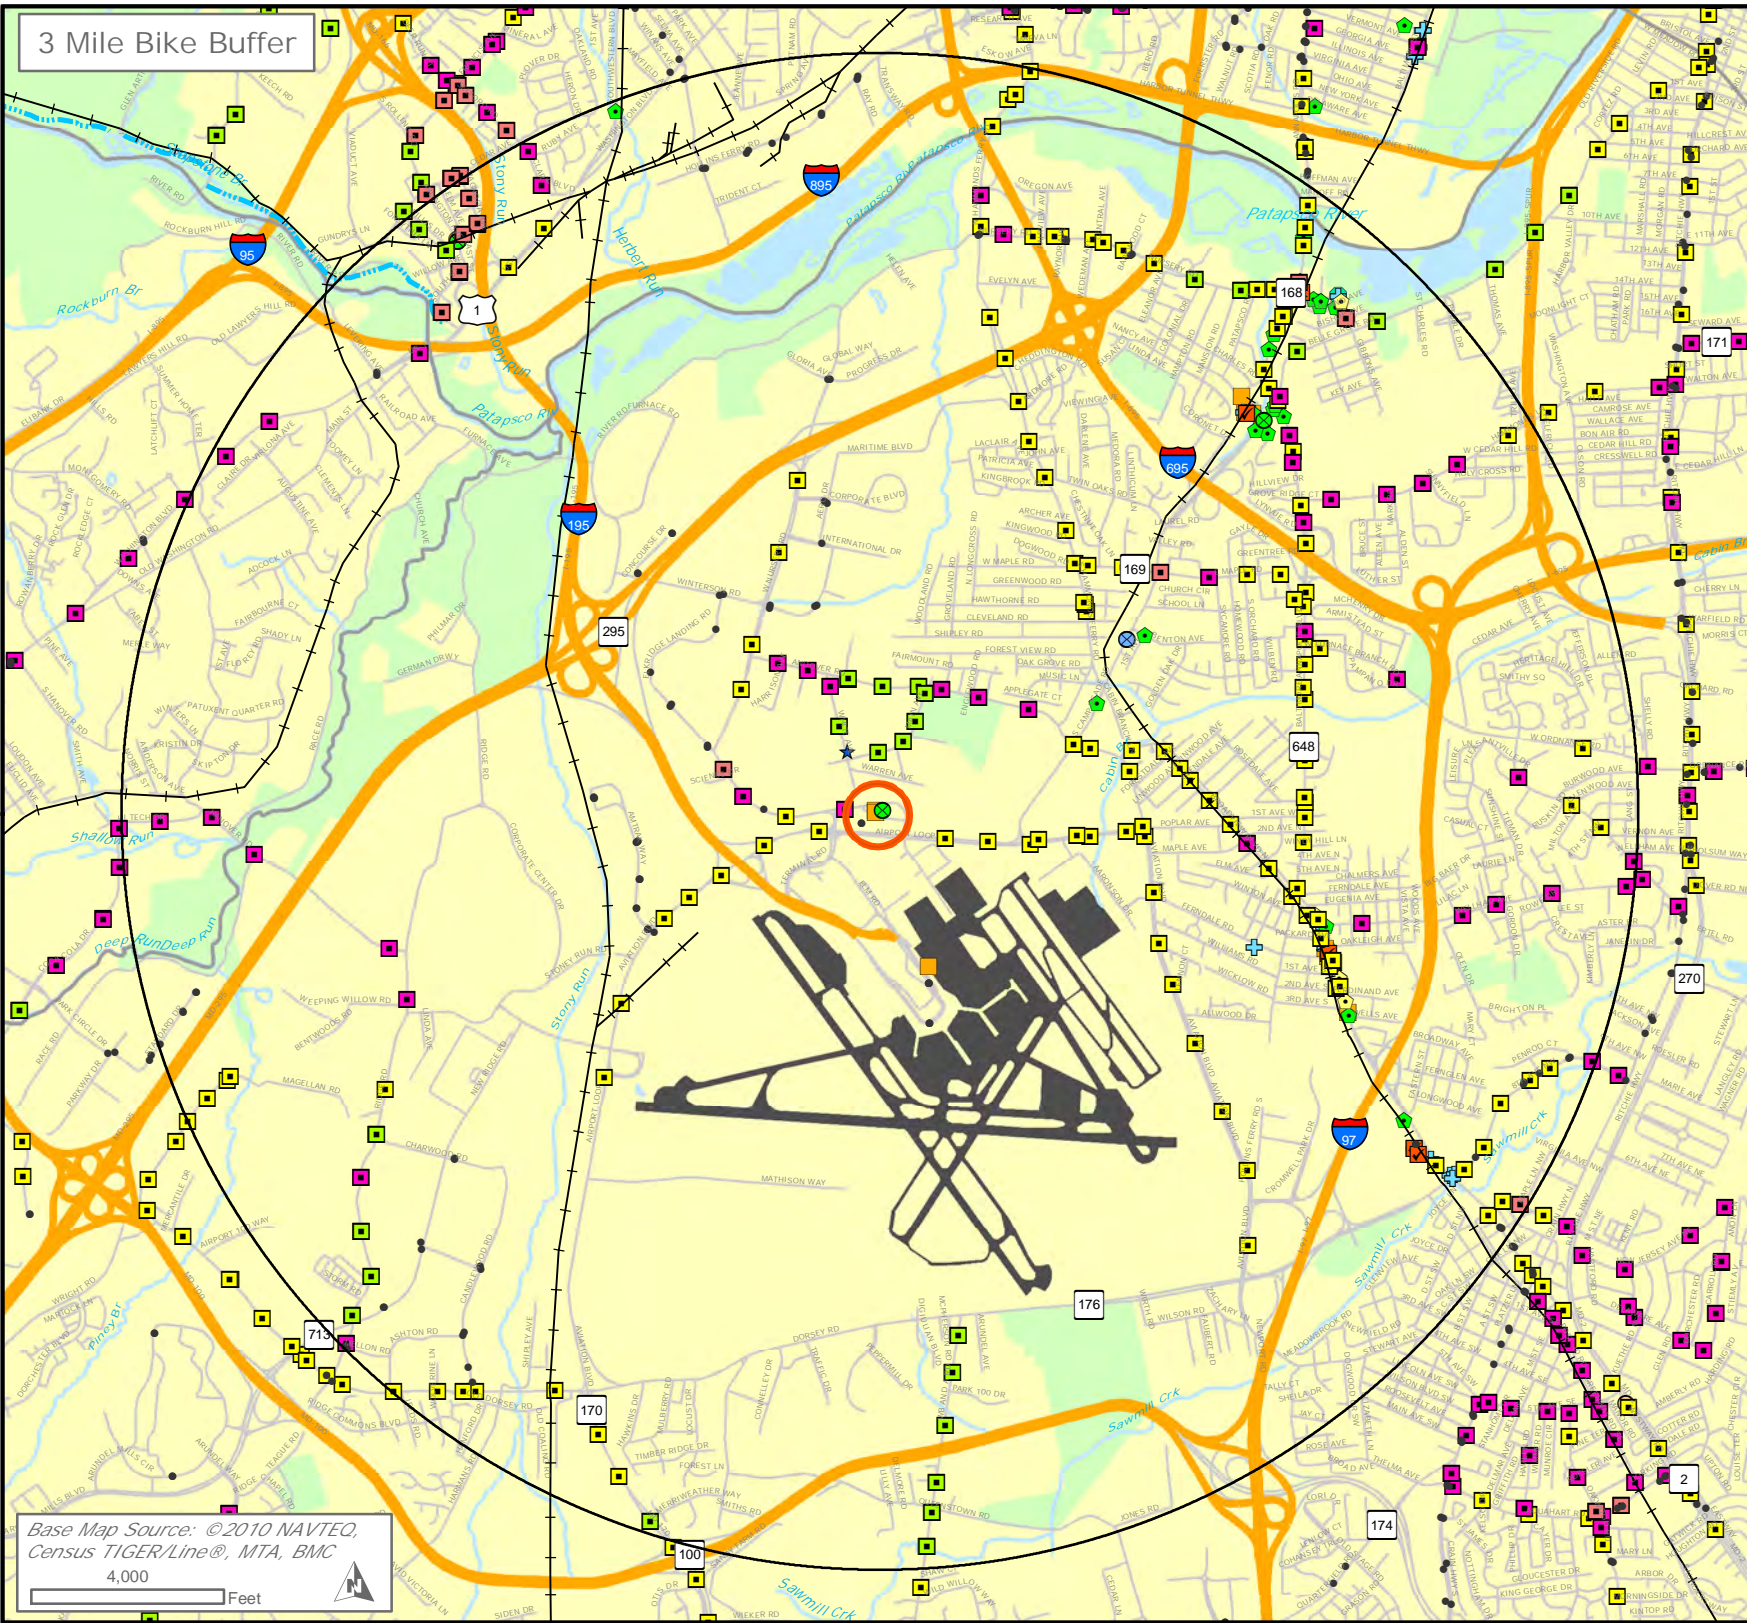
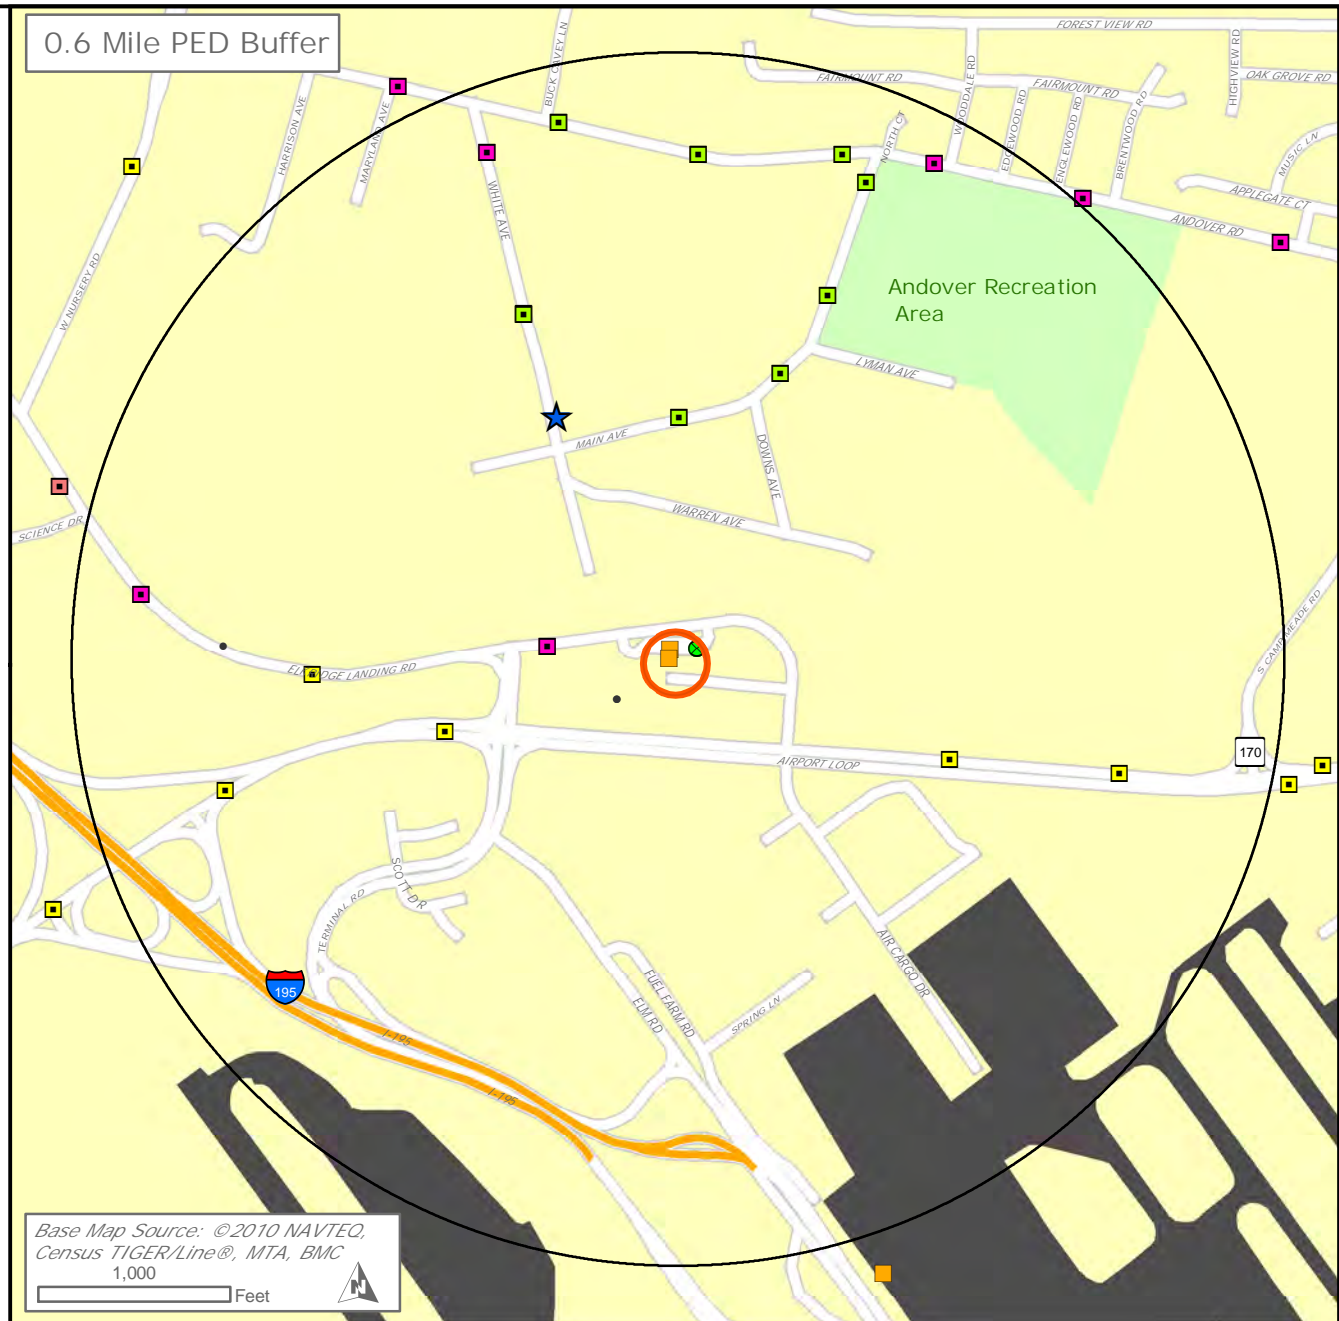
Existing Conditions

- A designated pedestrian path with crosswalks is recommended within the station parking area.

- To support shoulder use, signage and marking are recommended for segments of Nursery Road, MD 170 and MD 162.

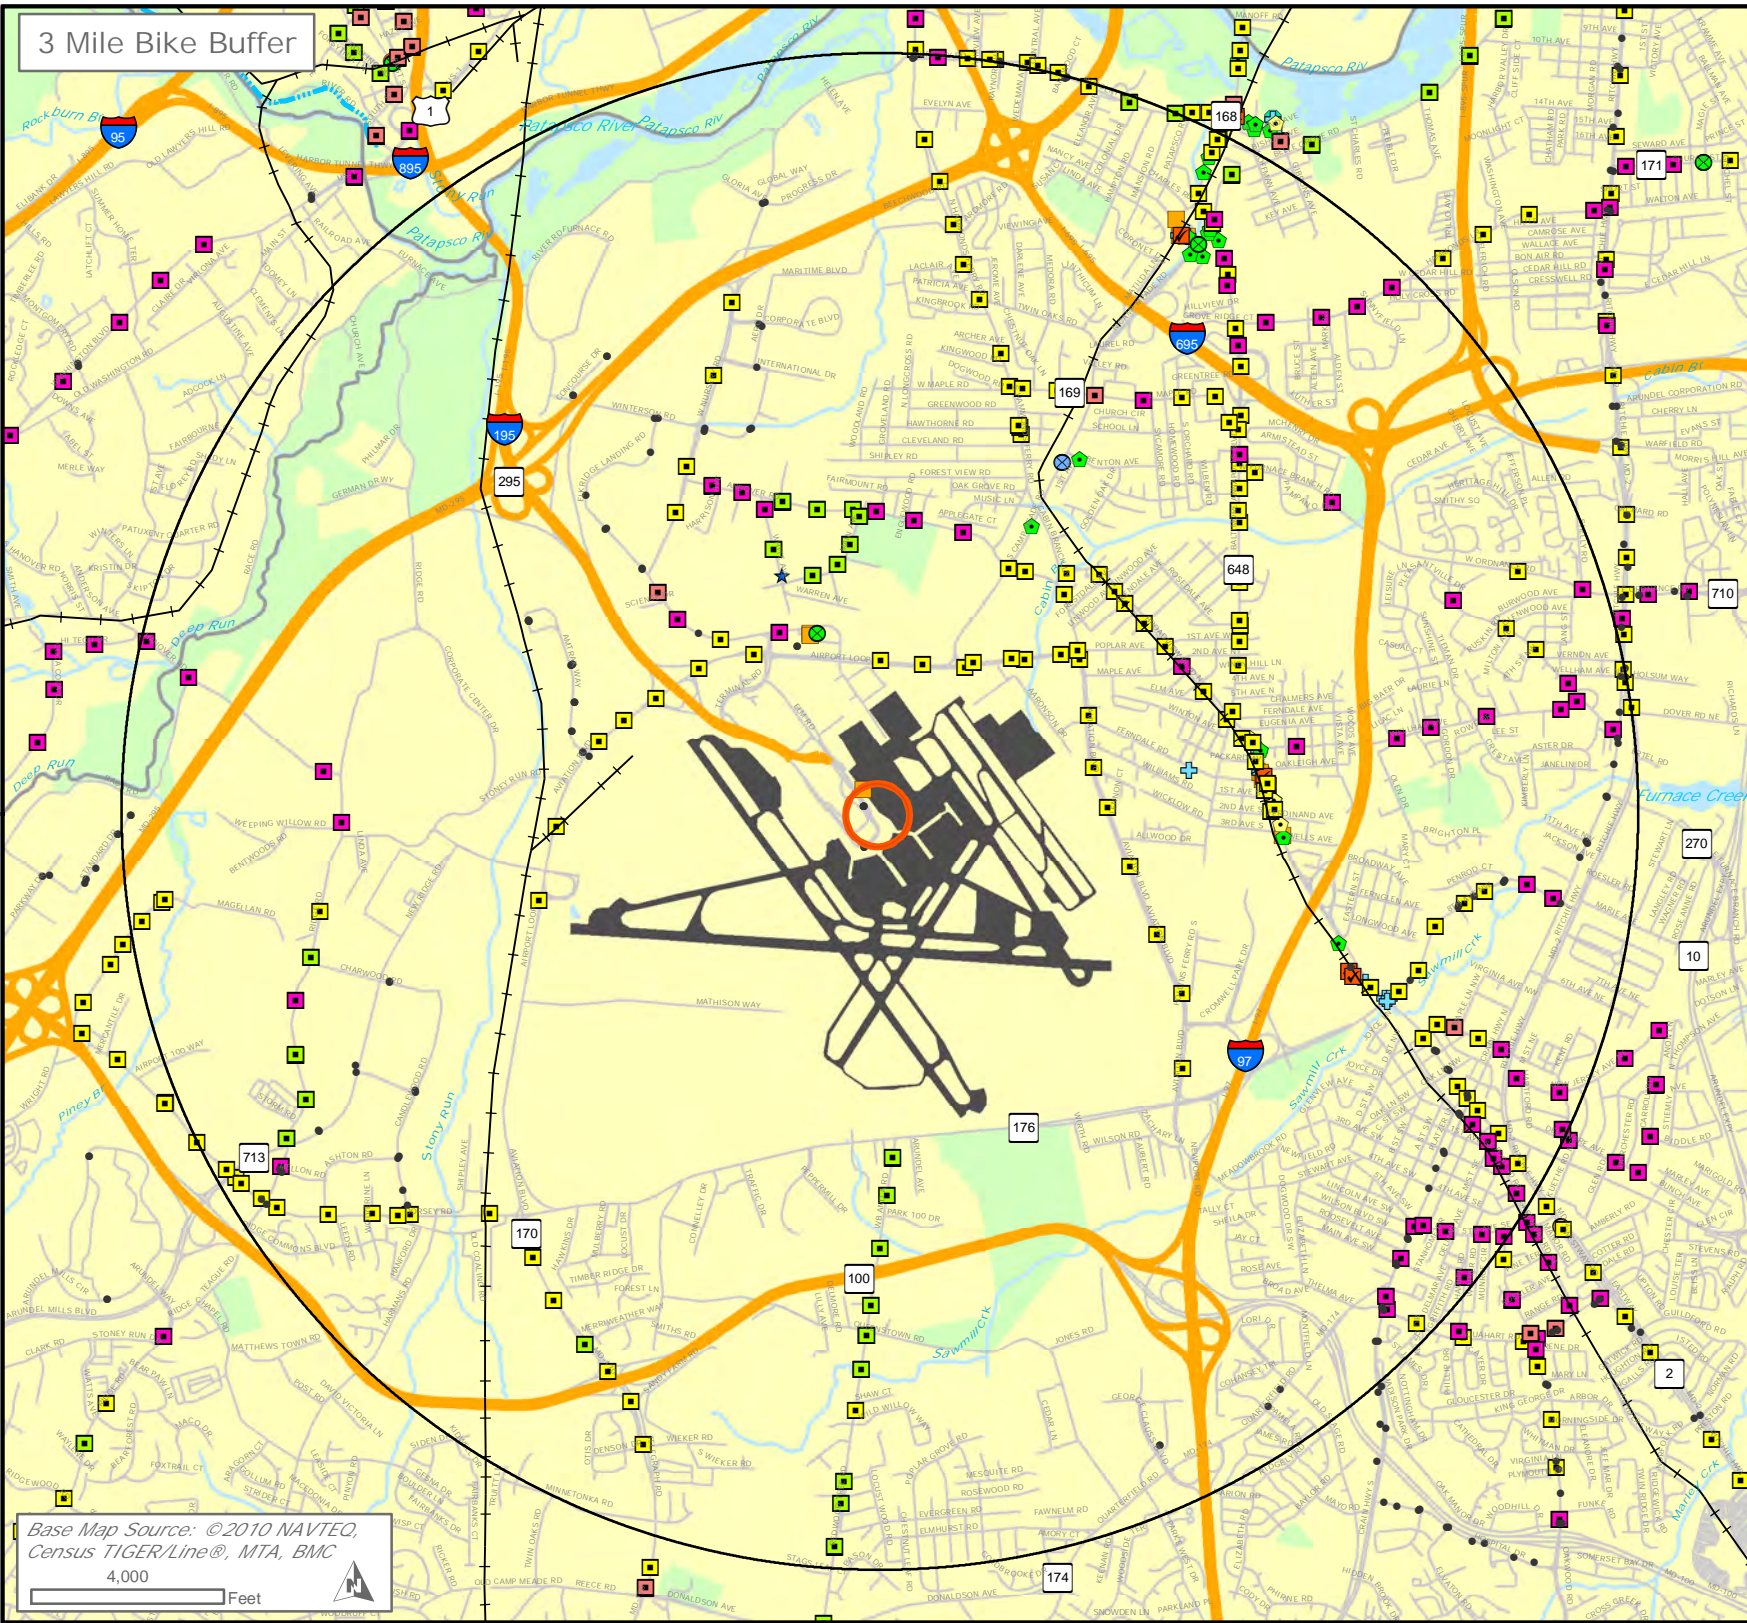
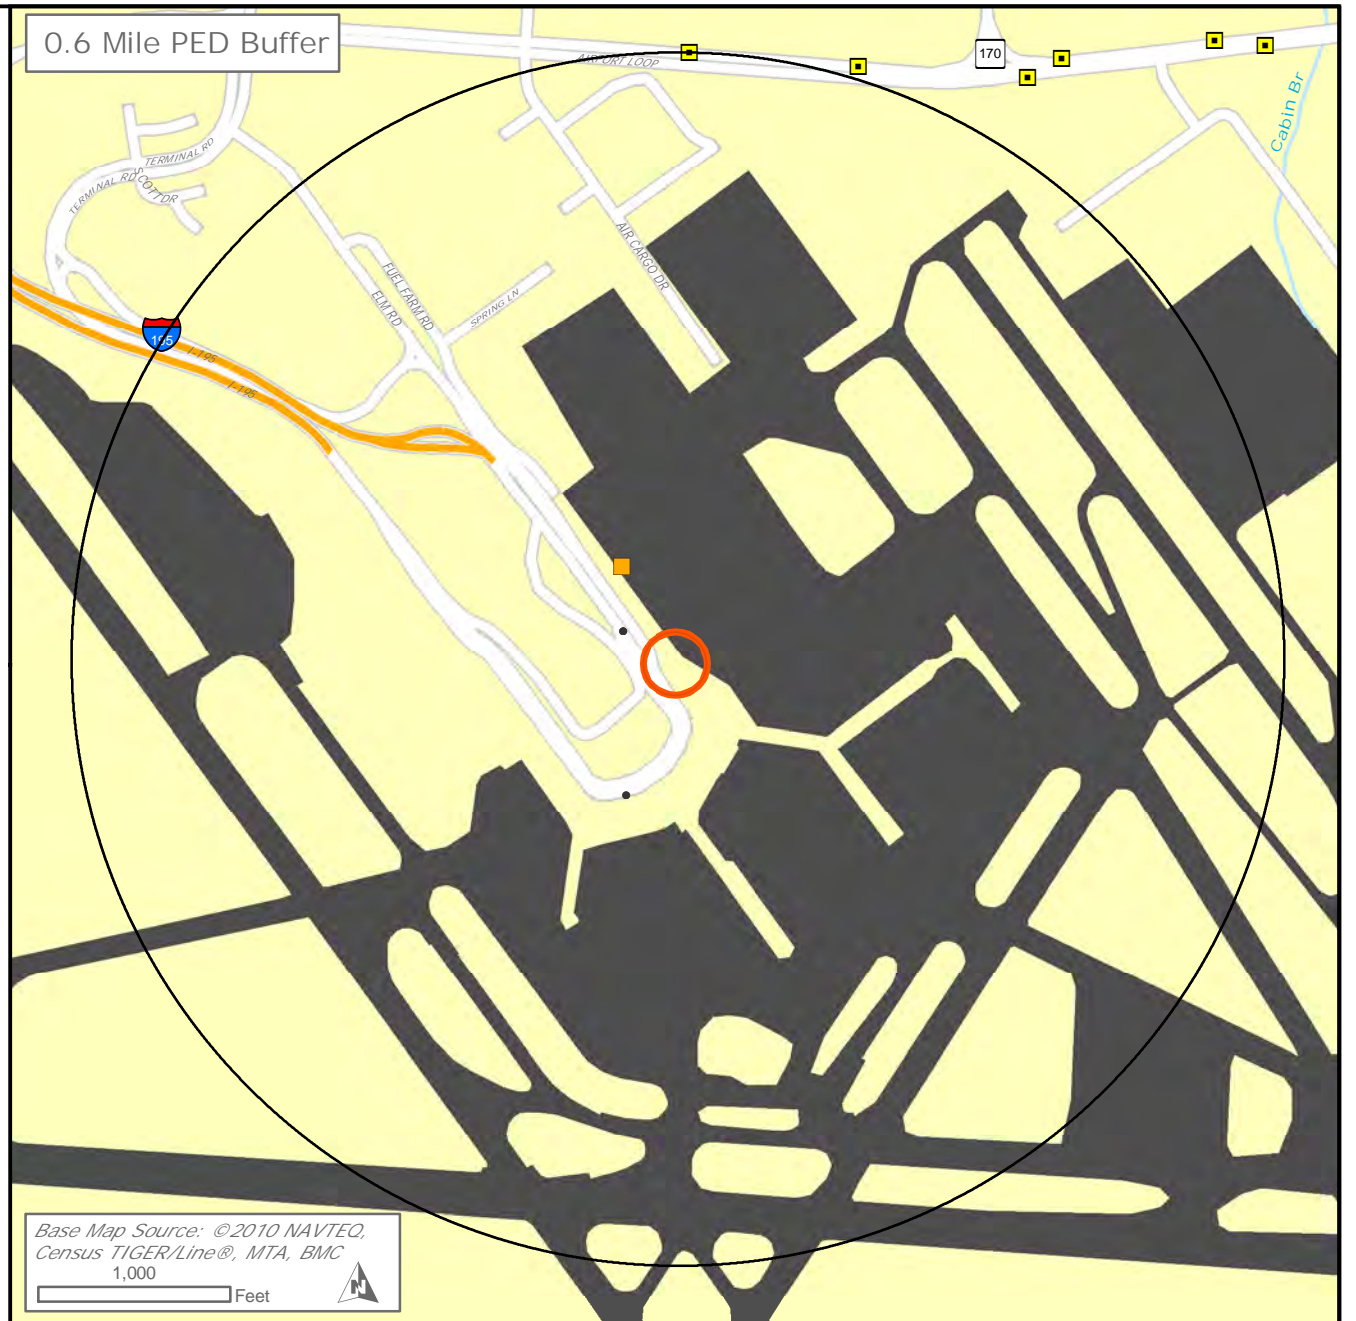
Existing Conditions

- Pedestrian crossing signs are recommended from the airport parking facility to the LRT station.
- Wayfinding signage could be improved for people seeking the station location from within the parking facility.

- Bicycling to the airport terminal or the light rail station therein is not advisable. Bicyclists can reach the BWI Business District station to access the Light Rail system.
